EA AND SUPPORTING SERVICES  
FOR THE TAMU SPACE INSTITUTE  
LEASE AT JSC

**NASA Johnson Space Center / TAMU Space Institute Historic Resources Survey**  
Surveyed by SWCA Environmental Consultants | Houston, Harris County, Texas

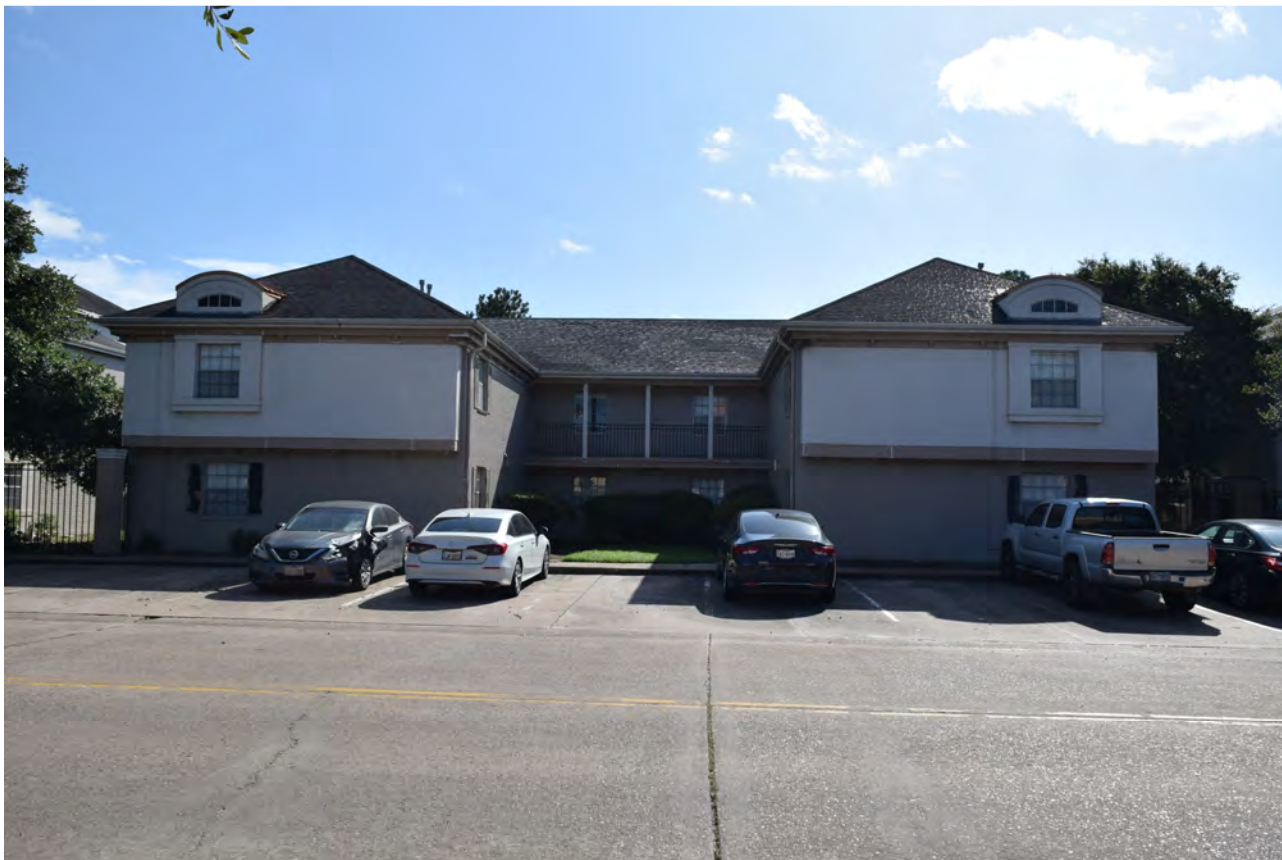
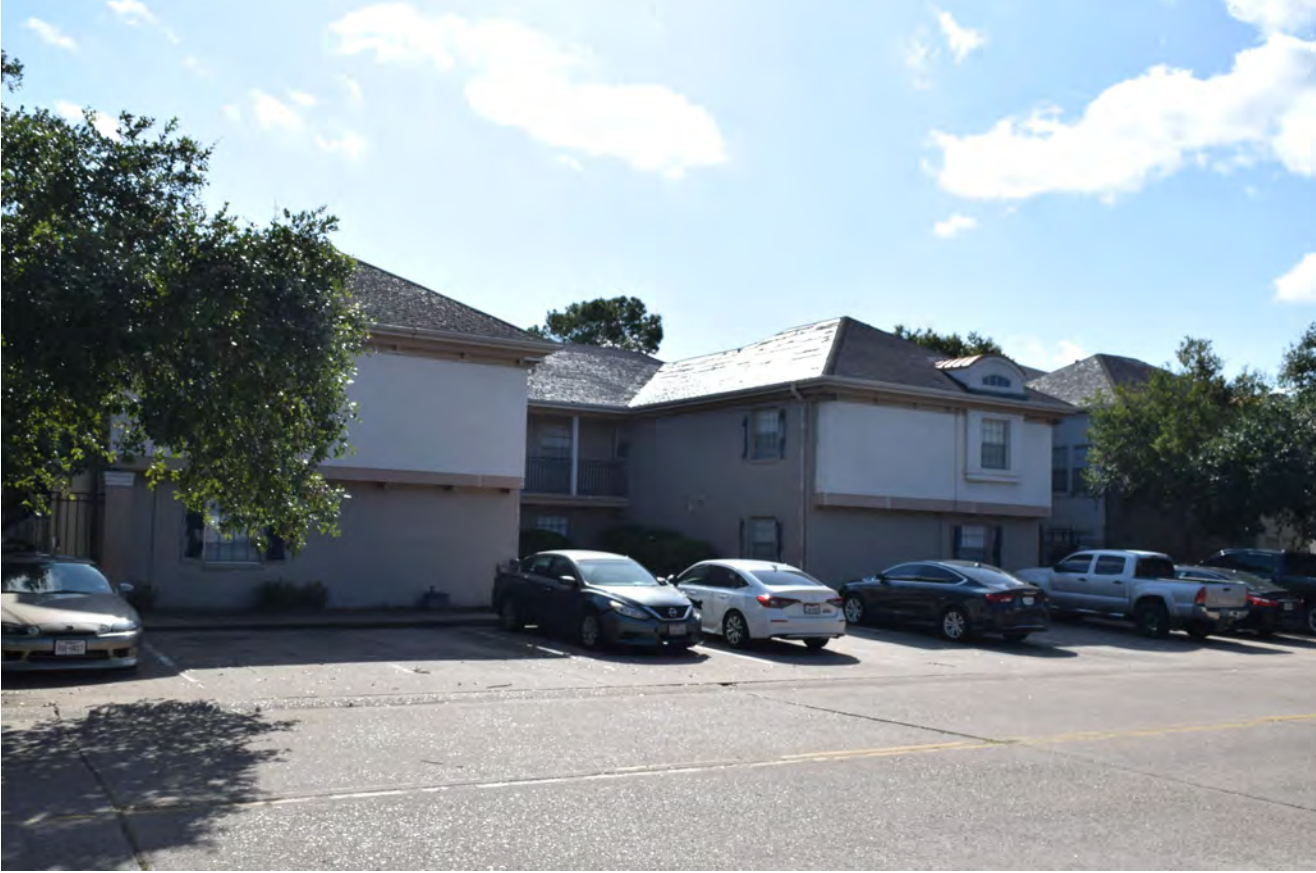
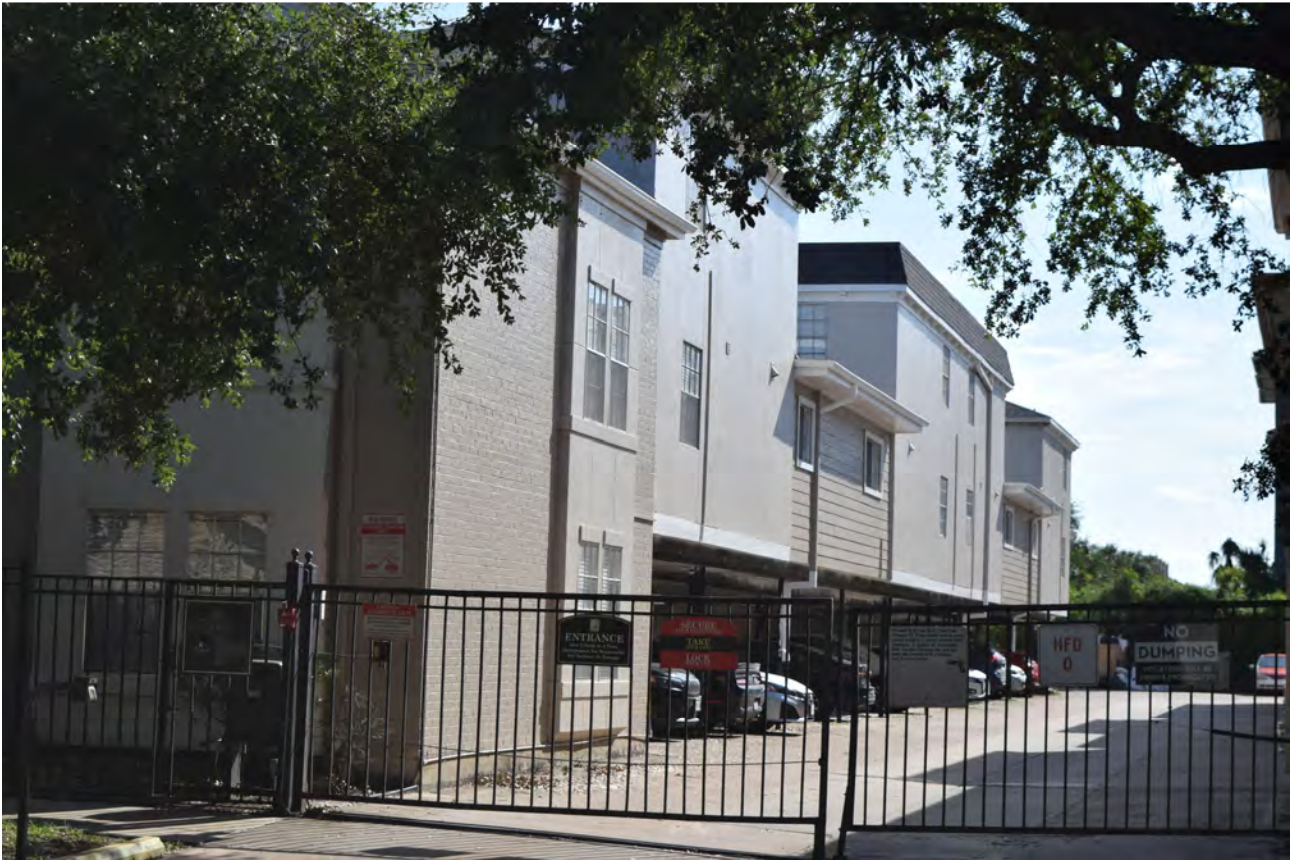
**Resource:** 9B      **Parcel:** 1003190000001  
**Name:** Regatta Apartments Homes Building 1  
**Location:** 1315 E NASA Pkwy  
**Historic Function:** Domestic/Multiple dwelling  
**Current Function:** Domestic/Multiple dwelling

View facing southwest

**Alterations:**  
Brick/stone painted  
Wall cladding replaced (some)  
Windows replaced (some)

This apartment building is not associated with significant events or individuals. The building does not feature distinctive architectural characteristics that represents a cohesive style. Painted brick and replaced materials diminish integrity of materials. The resource is unlikely to yield information potential. Therefore, the resource is recommended not eligible for the NRHP under Criteria A, B, C, or D.

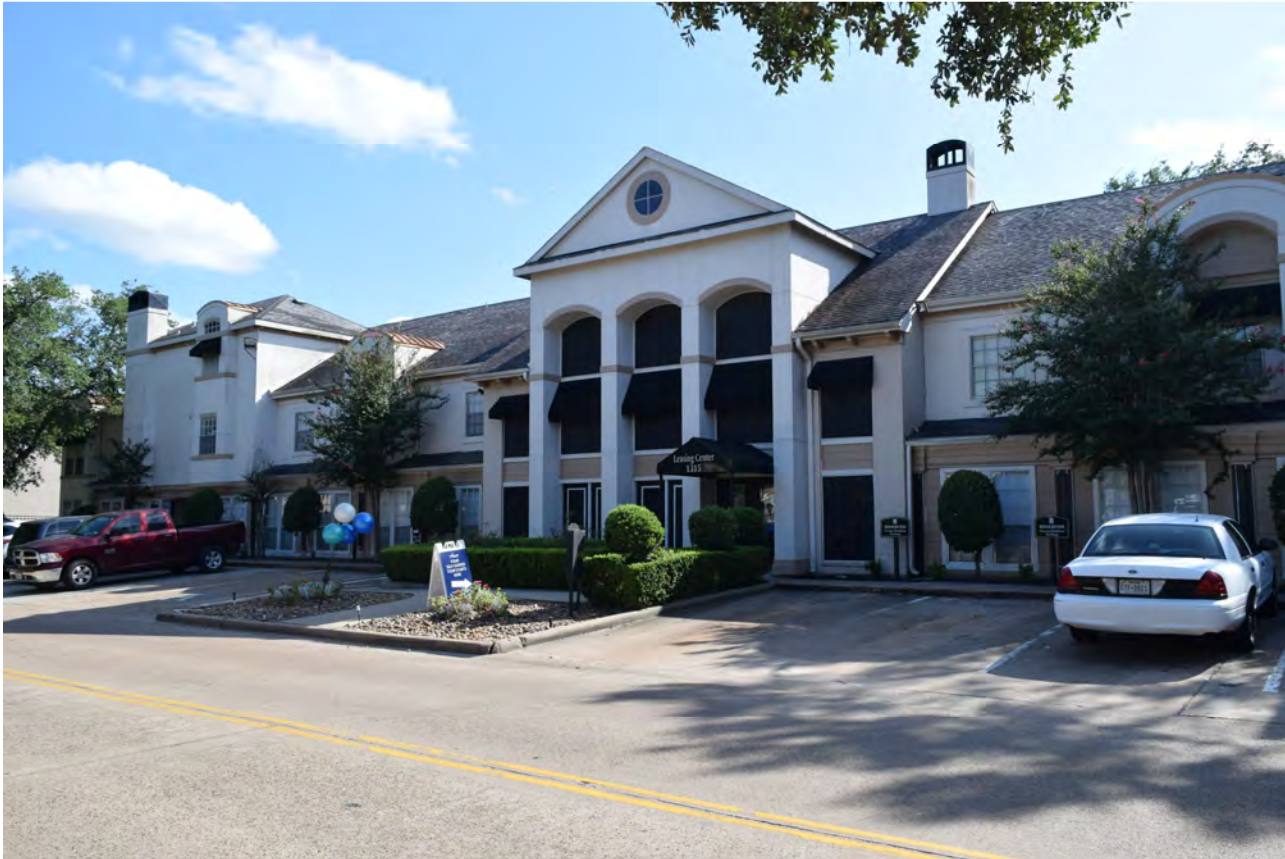
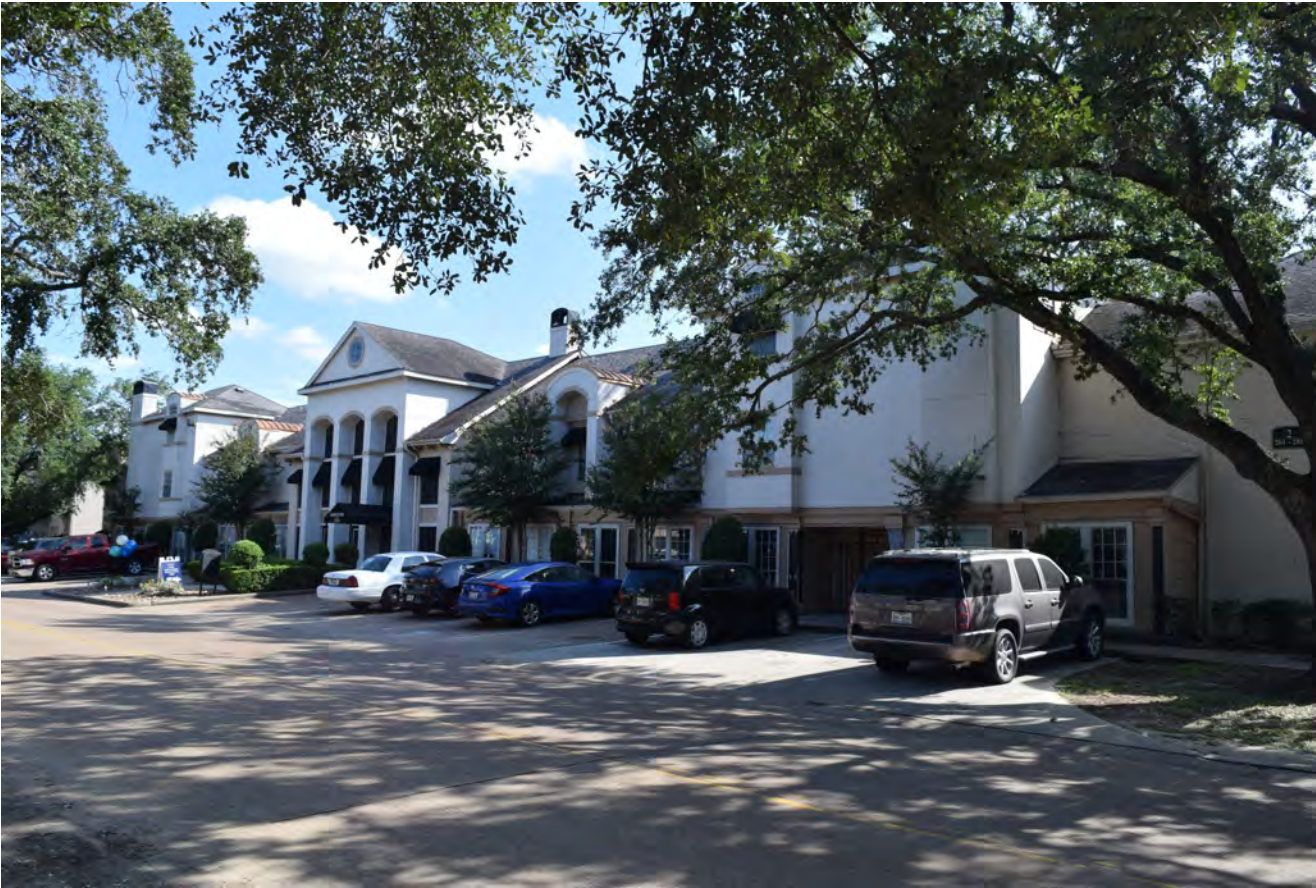
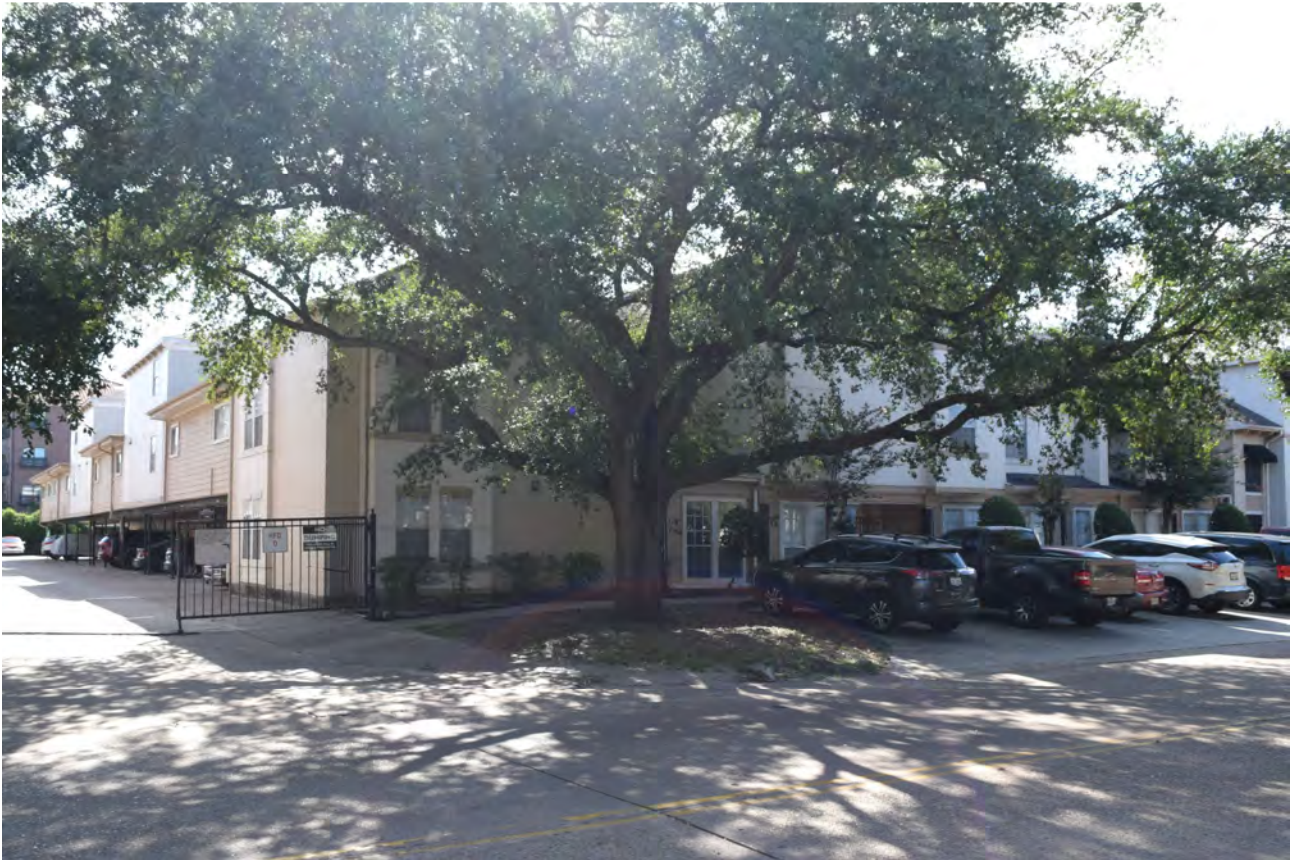
**Resource:** 9C      **Parcel:** 1003190000001  
**Name:** Regatta Apartments Homes Building 2  
**Location:** 1315 E NASA Pkwy  
**Historic Function:** Domestic/Multiple dwelling  
**Current Function:** Domestic/Multiple dwelling

View facing southwest (entrance detail)

**Alterations:**  
Awnings added  
Door(s) replaced (primary)  
Roof altered  
Windows replaced (some)

This apartment building is not associated with significant events or individuals. The building does not feature distinctive architectural characteristics that represents a cohesive style. Added awnings and replaced materials diminish integrity of materials. Altered roof hinders integrity of design. The resource is unlikely to yield information potential. Therefore, the resource is recommended not eligible for the NRHP under Criteria A, B, C, or D.

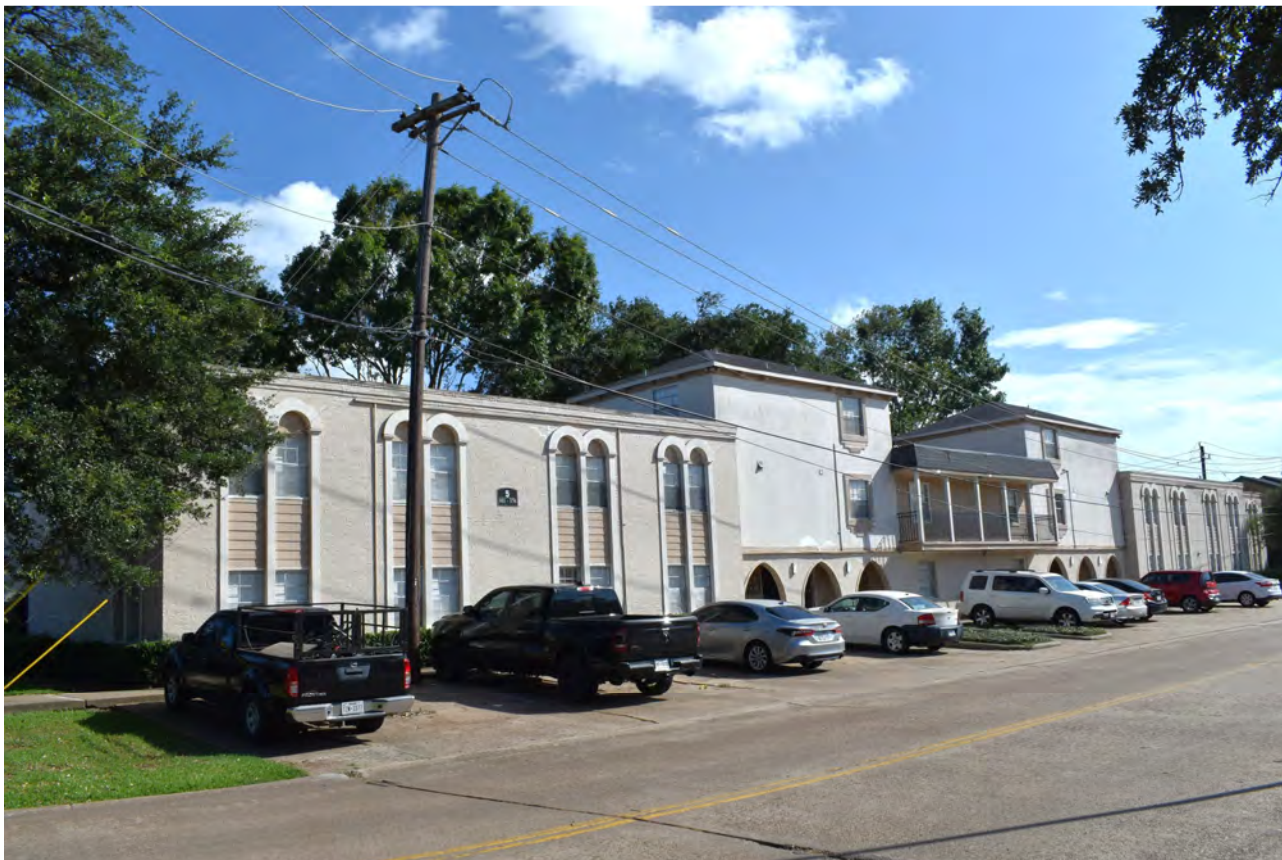
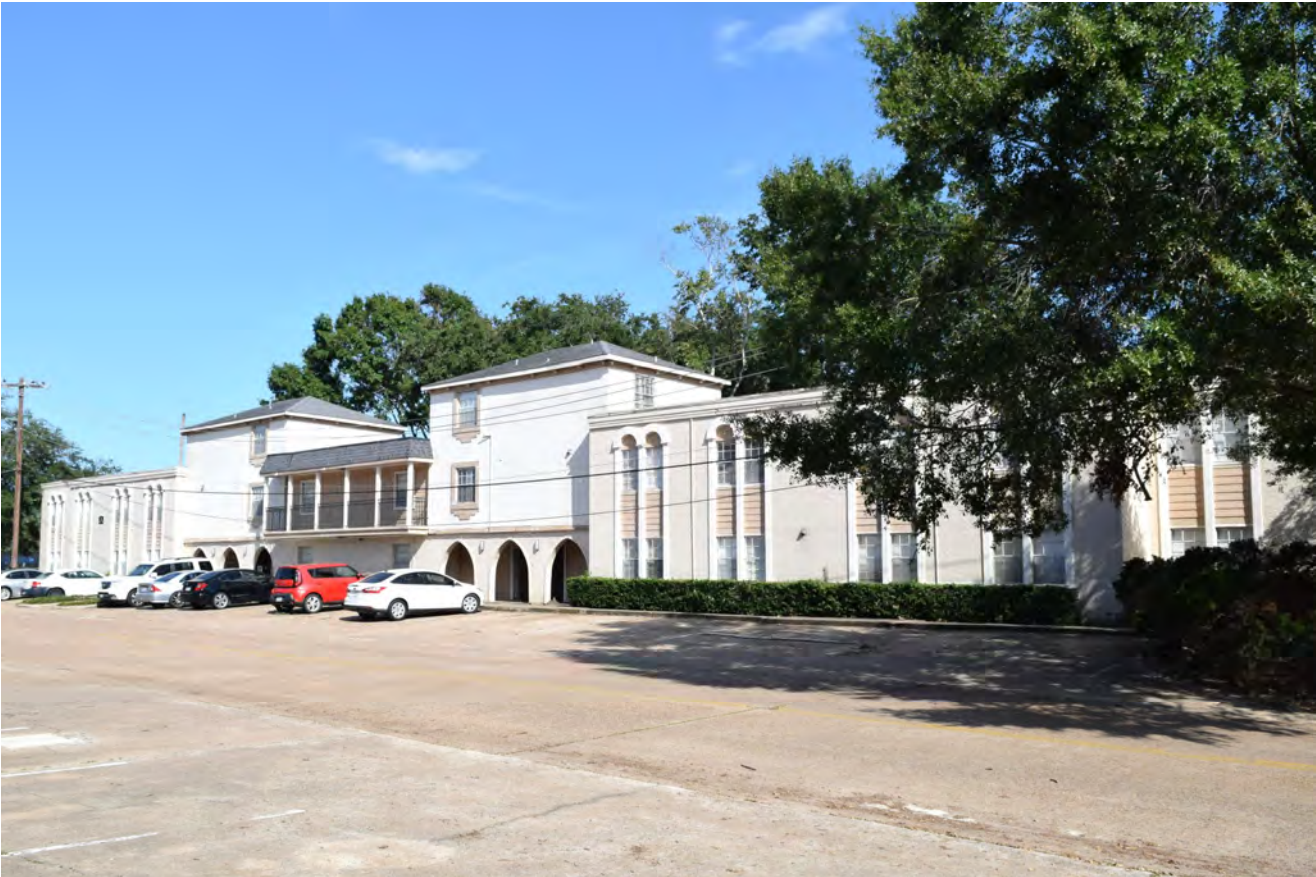
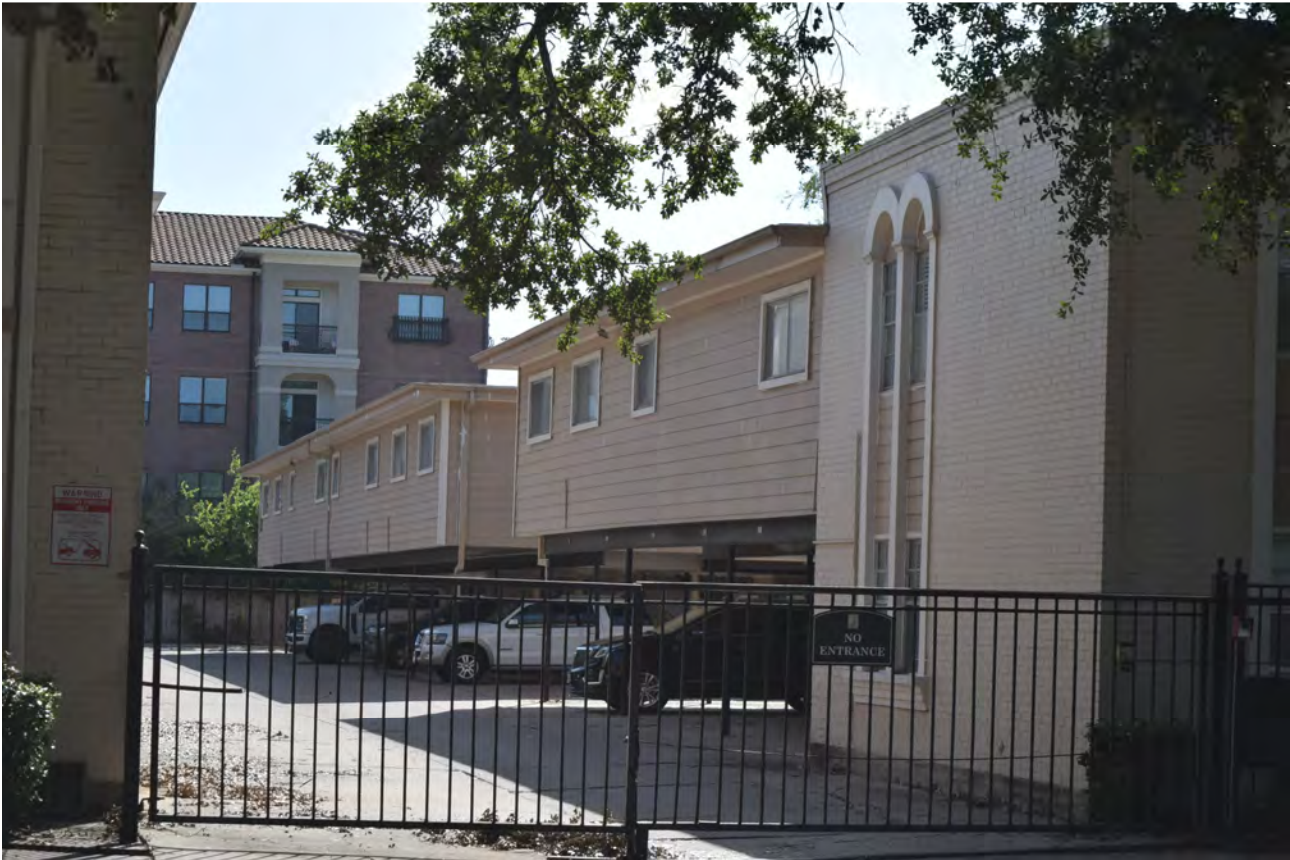
**Resource:** 9F      **Parcel:** 1003190000001  
**Name:** Regatta Apartments Homes Building 3  
**Location:** 1315 E NASA Pkwy  
**Historic Function:** Domestic/Multiple dwelling  
**Current Function:** Domestic/Multiple dwelling

View facing southwest

**Alterations:**  
Brick/stone painted  
Wall cladding replaced (some)

This apartment building is not associated with significant events or individuals. Although the buildings possesses elements of the Spanish Colonial Revival style, it is not significant within the context of the architectural style nor is it the work of a master. Painted brick and replaced materials diminish integrity of materials. The resource is unlikely to yield information potential. Therefore, the resource is recommended not eligible for the NRHP under Criteria A, B, C, or D.

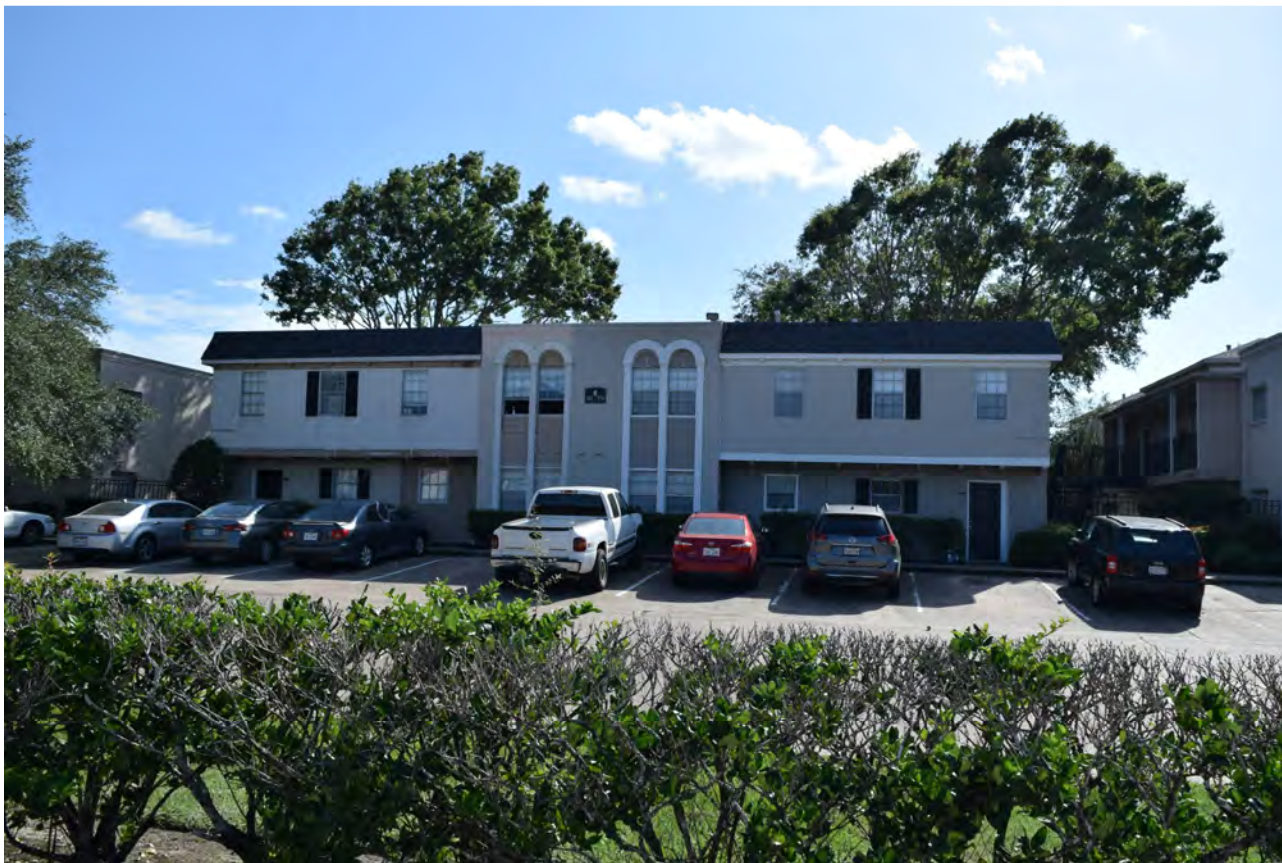
View facing southwest

<b>Type:</b> Building	<b>Primary roof form:</b> Flat w/parapet	<b>Roof material:</b> Tar or membrane	<b>Alterations:</b> Brick/stone painted Wall cladding replaced (some)
<b>Form:</b> Rectangular	<b>Porch:</b> Integrated partial-width	<b>Primary materials:</b> Brick Stucco Vinyl siding	
<b>Style:</b> Spanish Colonial Revival

This apartment building is not associated with significant events or individuals. Although the buildings possesses elements of the Spanish Colonial Revival style, it is not significant within the context of the architectural style nor is it the work of a master. Painted brick and replaced materials diminish integrity of materials. The resource is unlikely to yield information potential. Therefore, the resource is recommended not eligible for the NRHP under Criteria A, B, C, or D.

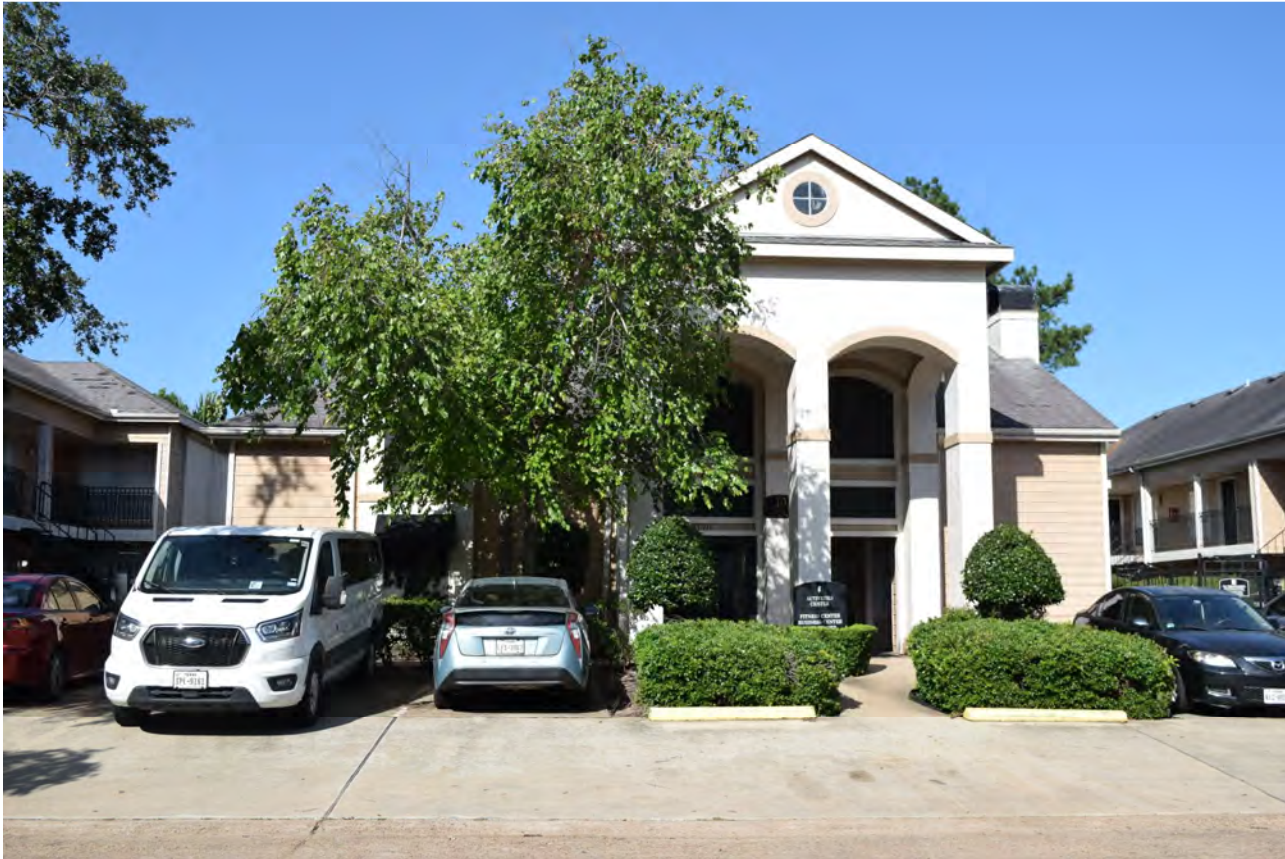
Resource 10A  
(Historic-age);  
view facing  
northeast

**Alterations:**  
Addition to front façade  
Door(s) replaced (primary)  
Roof altered  
Windows replaced (some)

The Regatta (East) apartment complex is not associated with significant events, important individuals, or notable architectural or planning characteristics. This complex is not associated with significant events or individuals. Although some buildings possess Late Modern style architecture, they are not a work of a master. Replaced materials lessen integrity of materials, and in some cases (like Resource 10A), additions to the front facade and changes to the roofline detract from the original design. The complex is unlikely to yield information potential. Therefore, the apartment complex and this resource are recommended not eligible for the NRHP under Criteria A, B, C, or D.

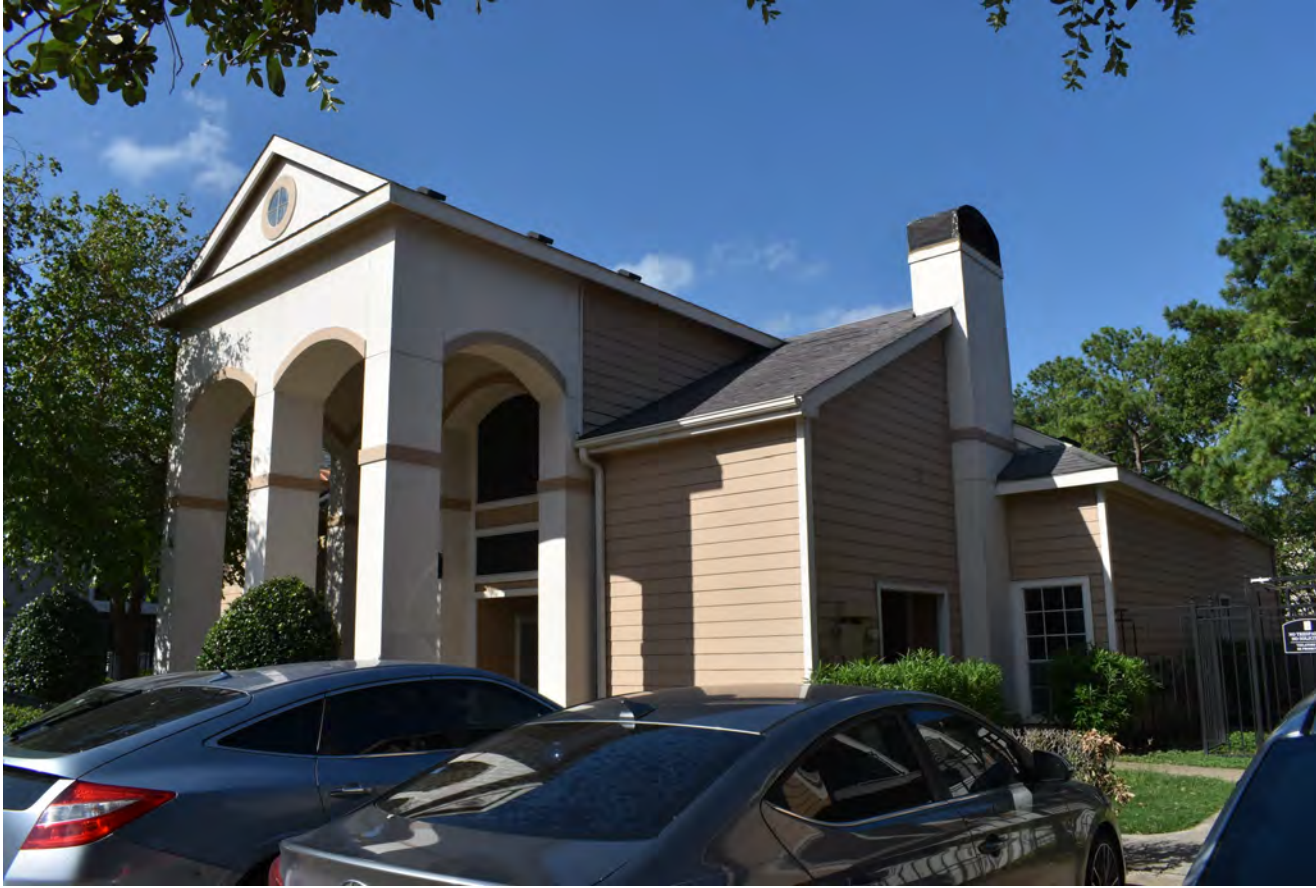
Resource  
10A (Historic-  
age); view  
facing  
northeast

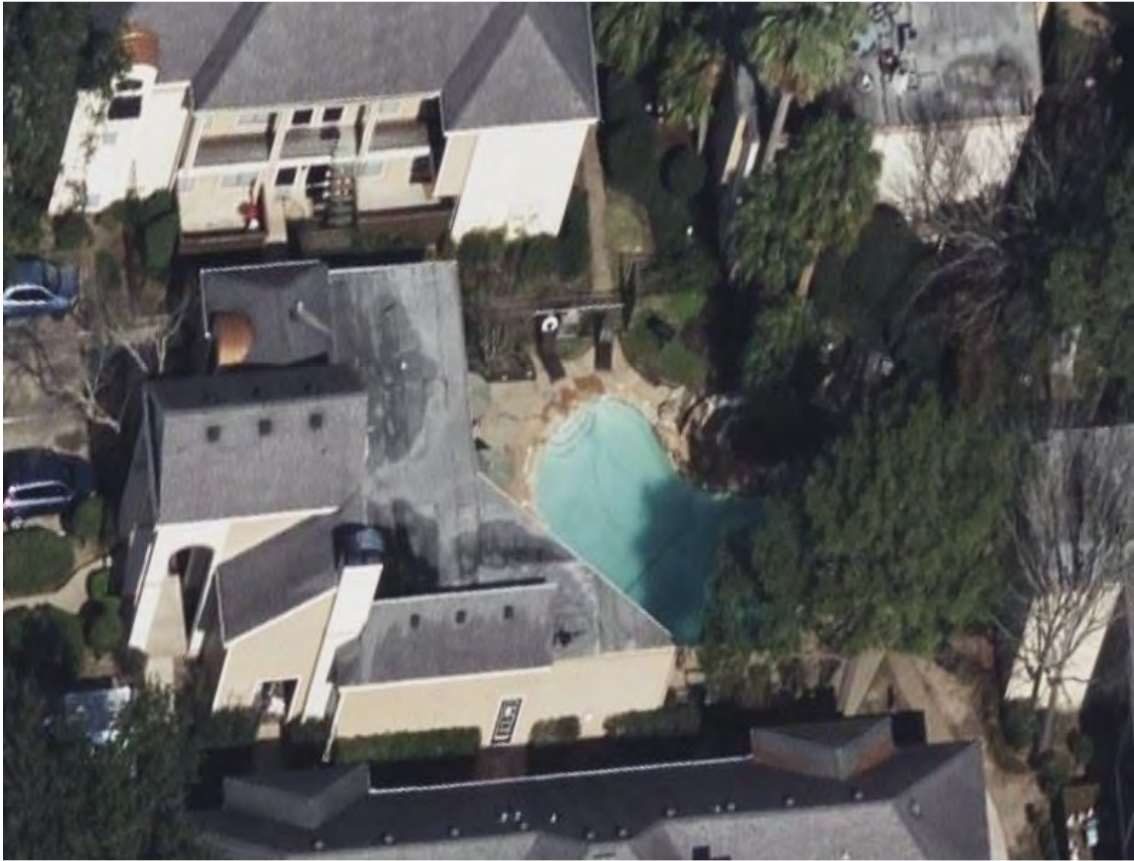
Oblique view  
facing north  
(Bing 2024)

Although this resource appears unaltered from aerial imagery, there is no evidence to support its significance. This common swimming pool resource is not associated with significant events or individuals. The structure does not possess distinctive elements and is not a work of a master. The resource is unlikely to yield information potential. Therefore, the resource is recommended not eligible for the NRHP under Criteria A, B, C, or D.

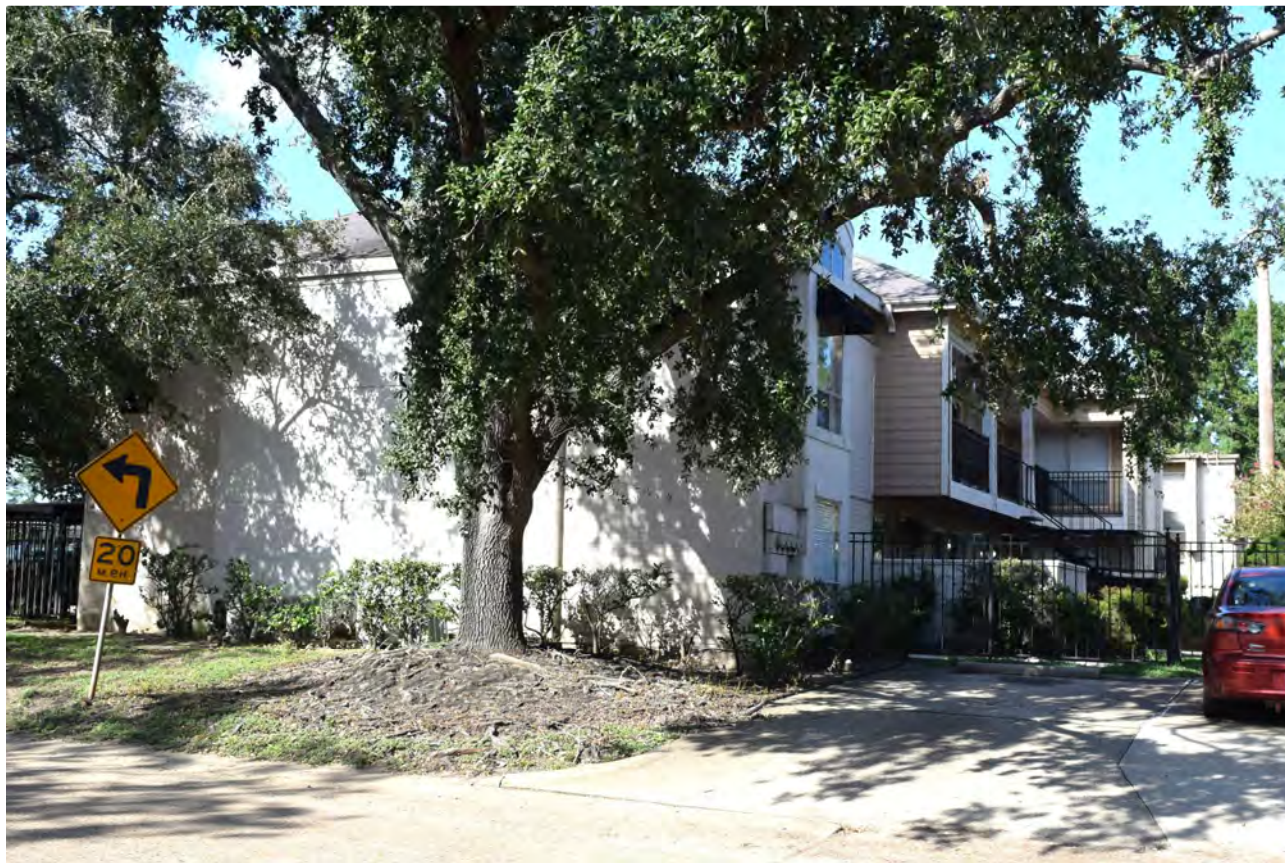
View facing northeast

**Alterations:**  
Brick/stone painted  
Dormers added  
Roofline altered  
Wall cladding replaced (some)  
Windows replaced (some)

This resource is not associated with significant events or individuals. The building does not possess distinctive elements and is not a work of a master. Painted brick and replaced materials lessen integrity of materials. Dormer additions and changes to the roofline detract from the original design. The resource is unlikely to yield information potential. Therefore, the resource is recommended not eligible for the NRHP under Criteria A, B, C, or D.

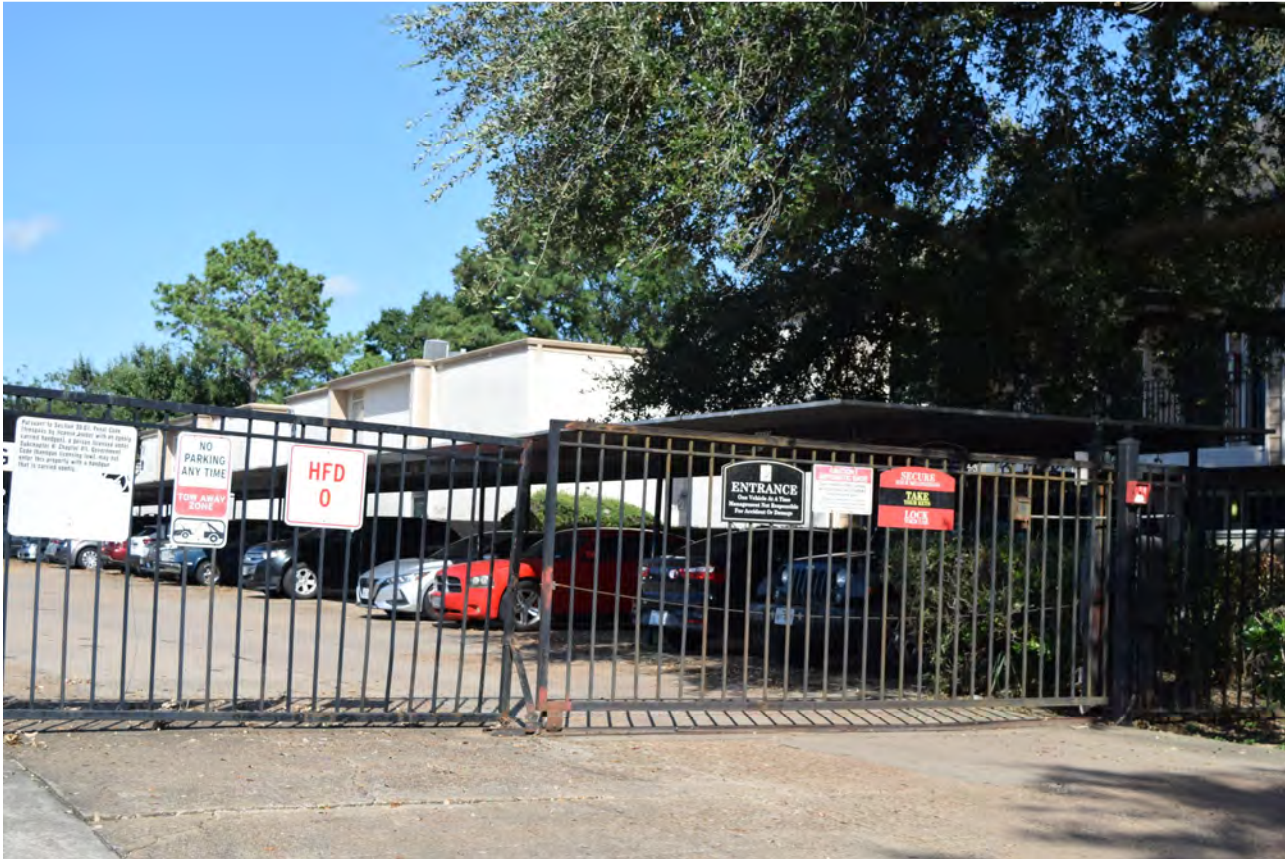
View facing east

This resource is not associated with significant events or individuals. The building does not possess distinctive elements and is not a work of a master. Painted brick diminishes integrity of materials. The resource is unlikely to yield information potential. Therefore, the resource is recommended not eligible for the NRHP under Criteria A, B, C, or D.

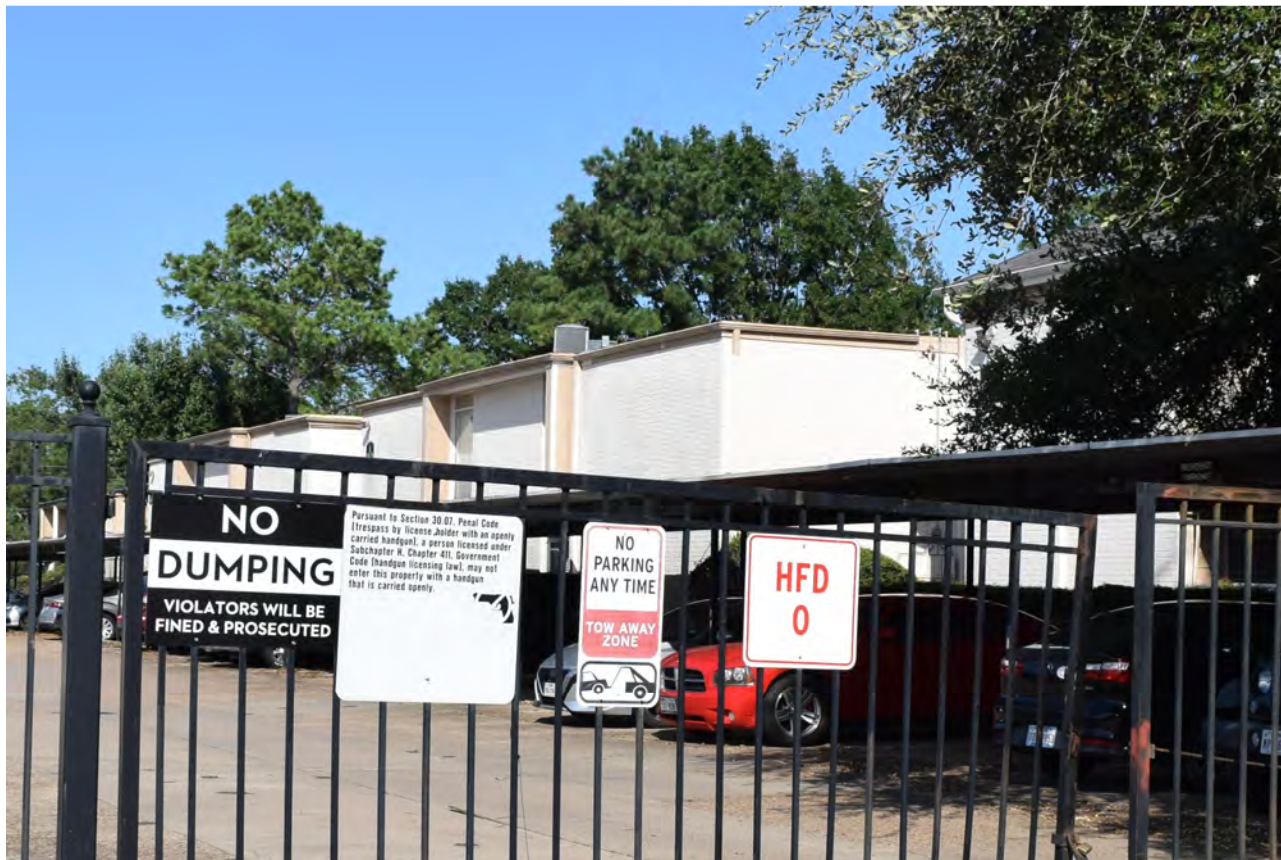
View facing east

This resource is not associated with significant events or individuals. The building does not possess distinctive elements and is not a work of a master. Painted brick diminishes integrity of materials. The resource is unlikely to yield information potential. Therefore, the resource is recommended not eligible for the NRHP under Criteria A, B, C, or D.

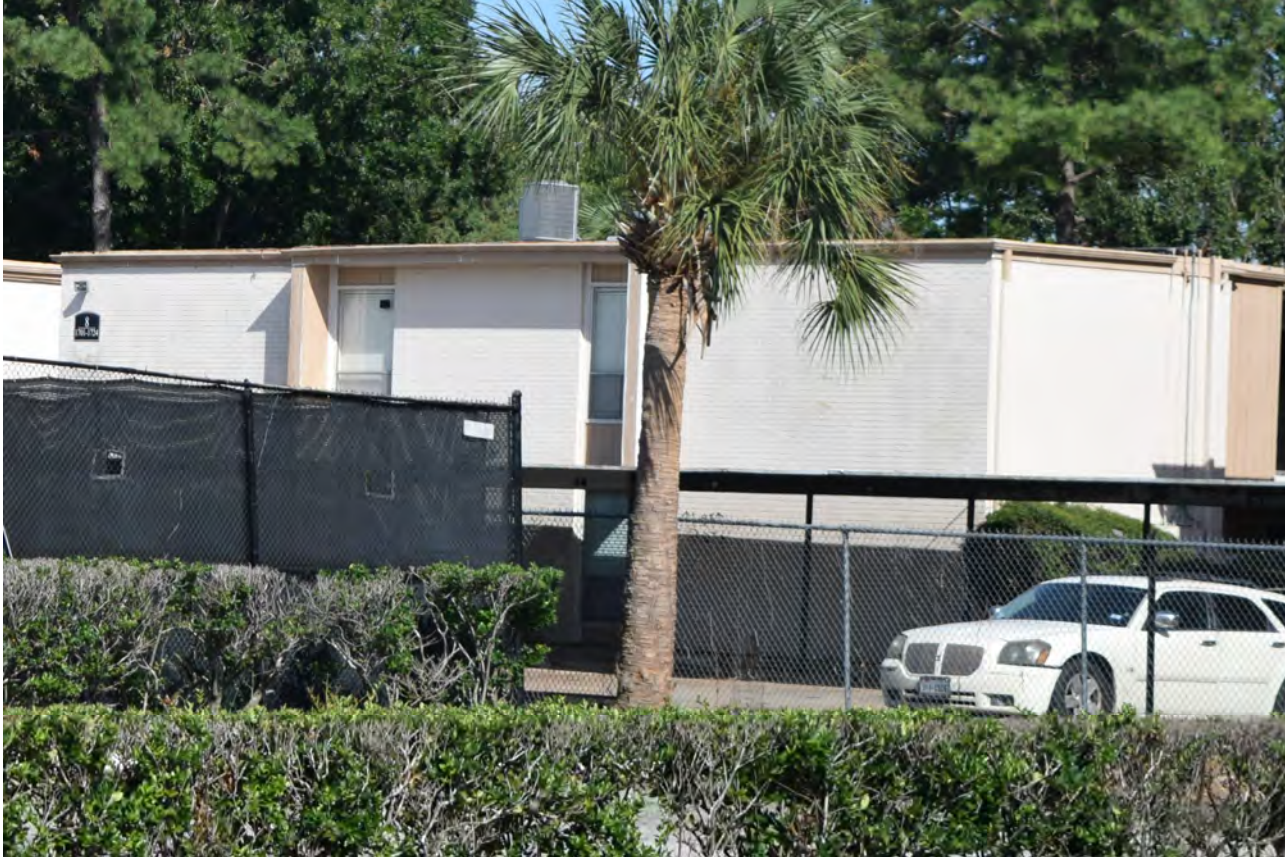
View facing east

This resource is not associated with significant events or individuals. The building does not possess distinctive elements and is not a work of a master. Painted brick diminishes integrity of materials. The resource is unlikely to yield information potential. Therefore, the resource is recommended not eligible for the NRHP under Criteria A, B, C, or D.

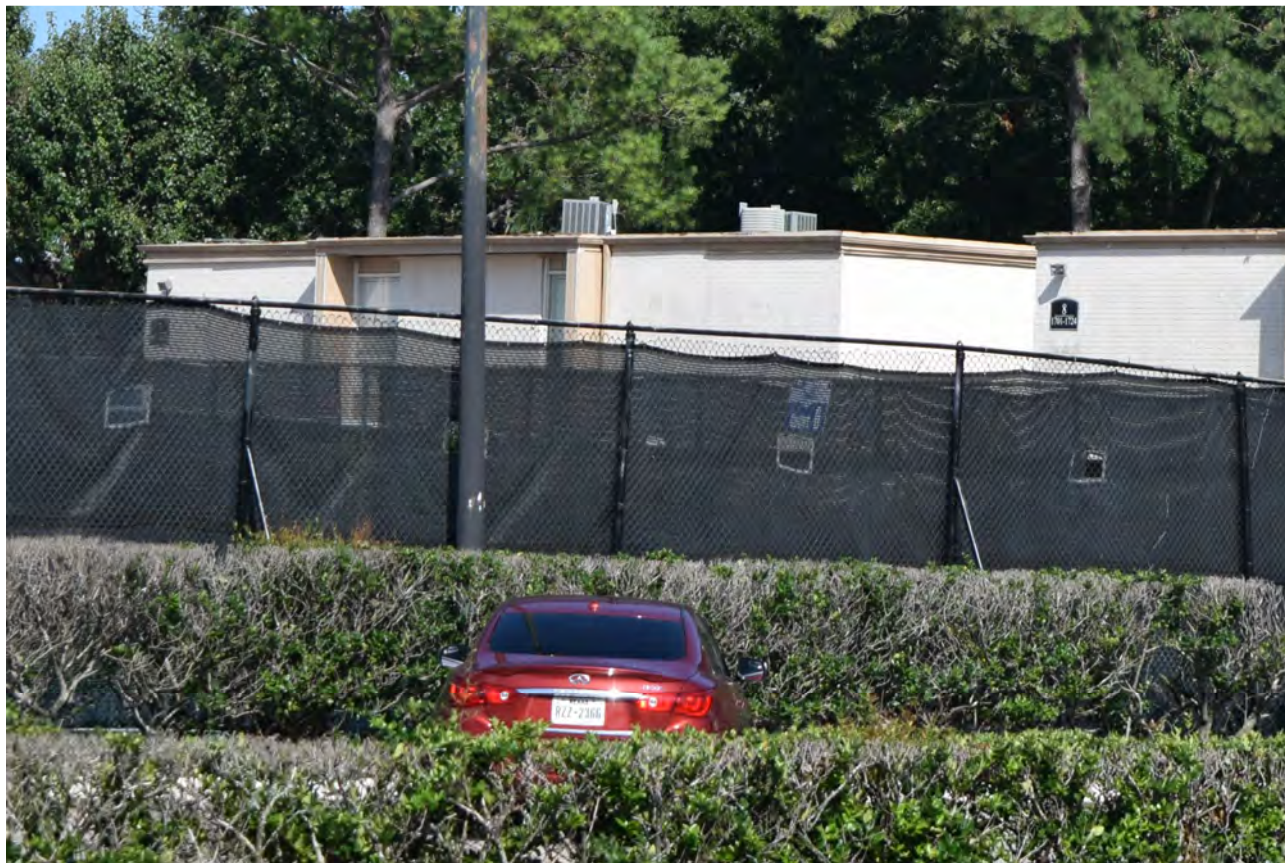
View facing east

This resource is not associated with significant events or individuals. The building does not possess distinctive elements and is not a work of a master. Painted brick diminishes integrity of materials. The resource is unlikely to yield information potential. Therefore, the resource is recommended not eligible for the NRHP under Criteria A, B, C, or D.

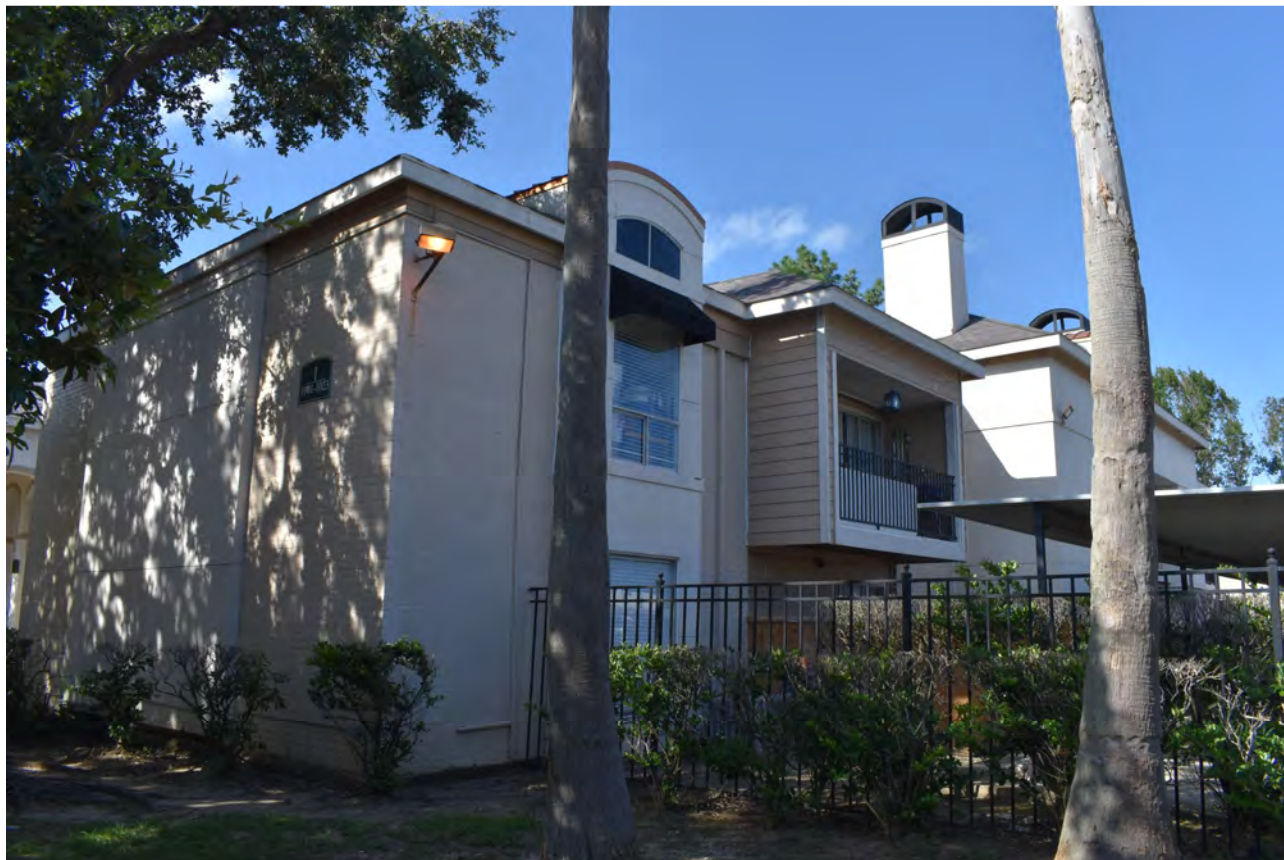
View facing  
northeast

**Alterations:**  
Brick/stone painted  
Dormers added  
Roof altered  
Window(s) replaced (all)  
Wall cladding replaced (some)

This resource is not associated with significant events or individuals. The building does not possess distinctive elements and is not a work of a master. Painted brick diminishes integrity of materials. Dormer additions and changes to the roofline detract from the original design. The resource is unlikely to yield information potential. Therefore, the resource is recommended not eligible for the NRHP under Criteria A, B, C, or D.
