EA AND SUPPORTING SERVICES  
FOR THE TAMU SPACE INSTITUTE  
LEASE AT JSC

**NASA Johnson Space Center / TAMU Space Institute Historic Resources Survey**  
Surveyed by SWCA Environmental Consultants | Houston, Harris County, Texas

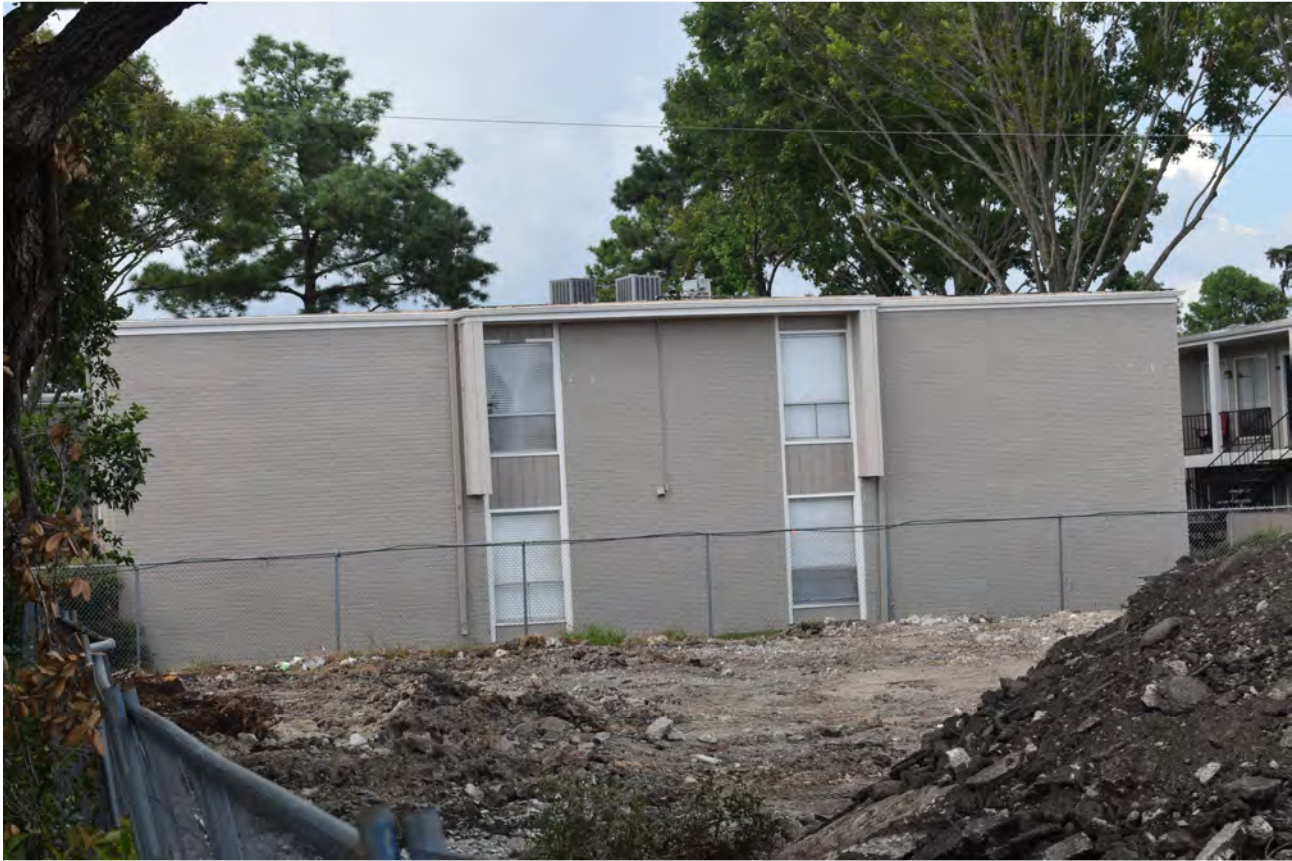
Oblique view  
facing north  
(Bing 2024)

This resource is not associated with significant events or individuals. The building does not possess distinctive elements and is not a work of a master. Painted brick diminishes integrity of materials. The resource is unlikely to yield information potential. Therefore, the resource is recommended not eligible for the NRHP under Criteria A, B, C, or D.

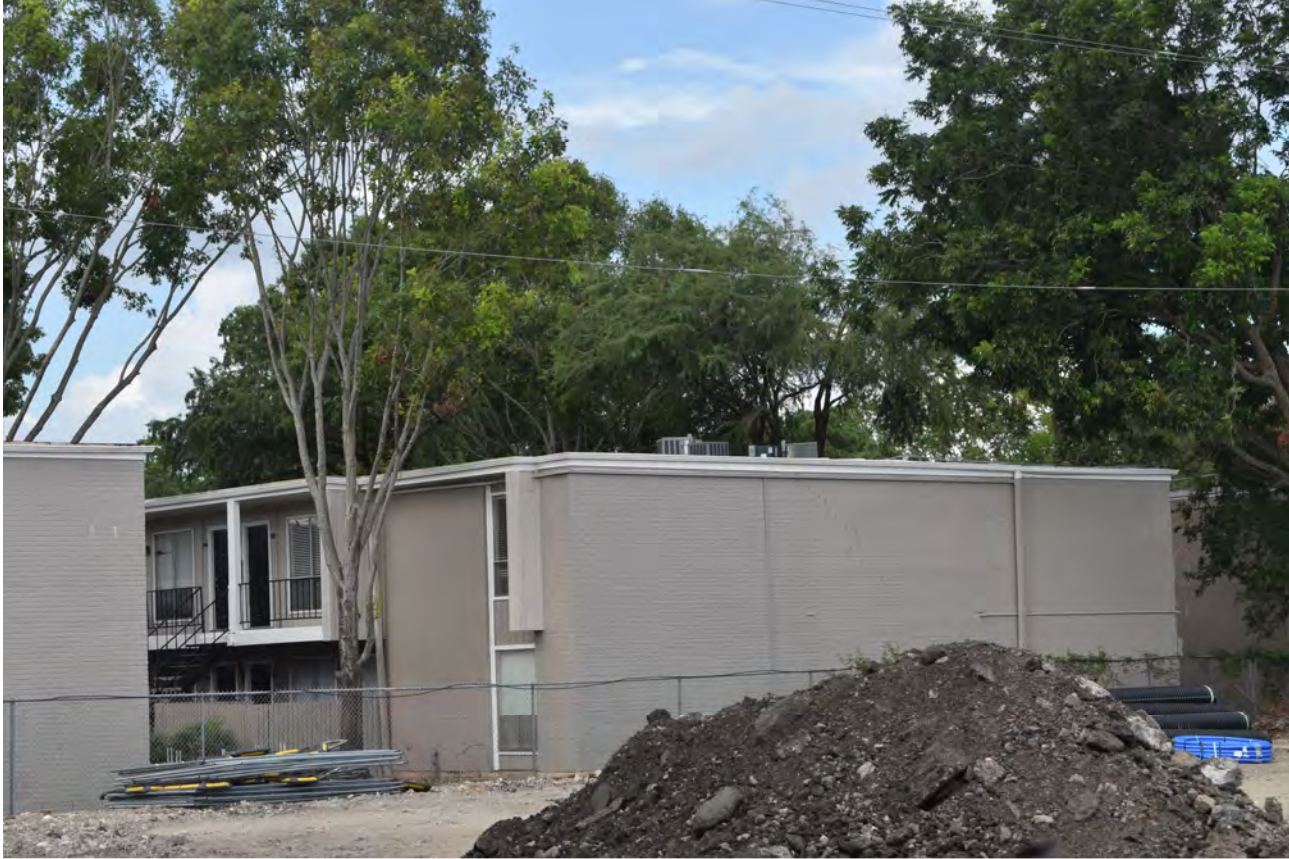
View facing  
north

This resource is not associated with significant events or individuals. The building does not possess distinctive elements and is not a work of a master. Painted brick diminishes integrity of materials. The resource is unlikely to yield information potential. Therefore, the resource is recommended not eligible for the NRHP under Criteria A, B, C, or D.

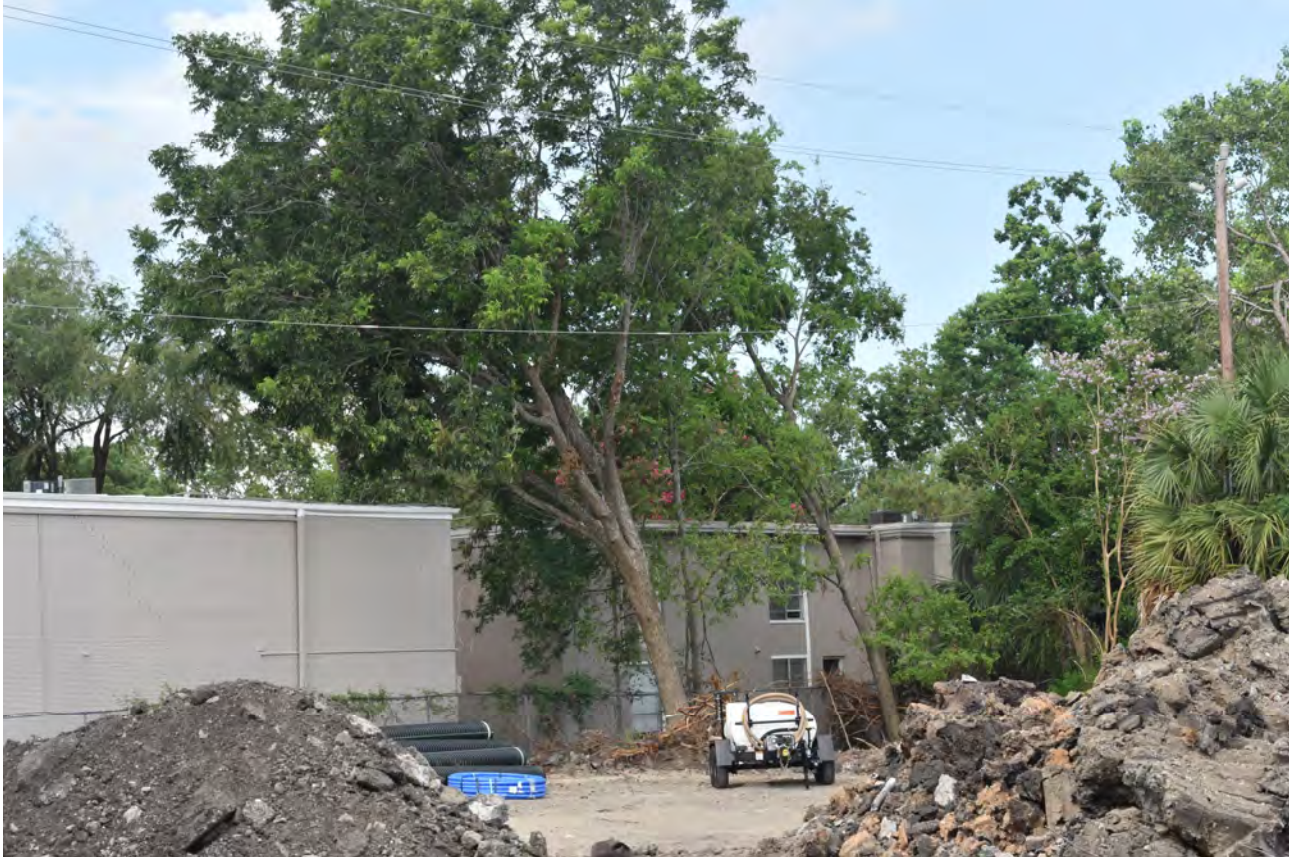
View facing  
north; resource  
on right

This resource is not associated with significant events or individuals. The building does not possess distinctive elements and is not a work of a master. Painted brick diminishes integrity of materials. The resource is unlikely to yield information potential. Therefore, the resource is recommended not eligible for the NRHP under Criteria A, B, C, or D.

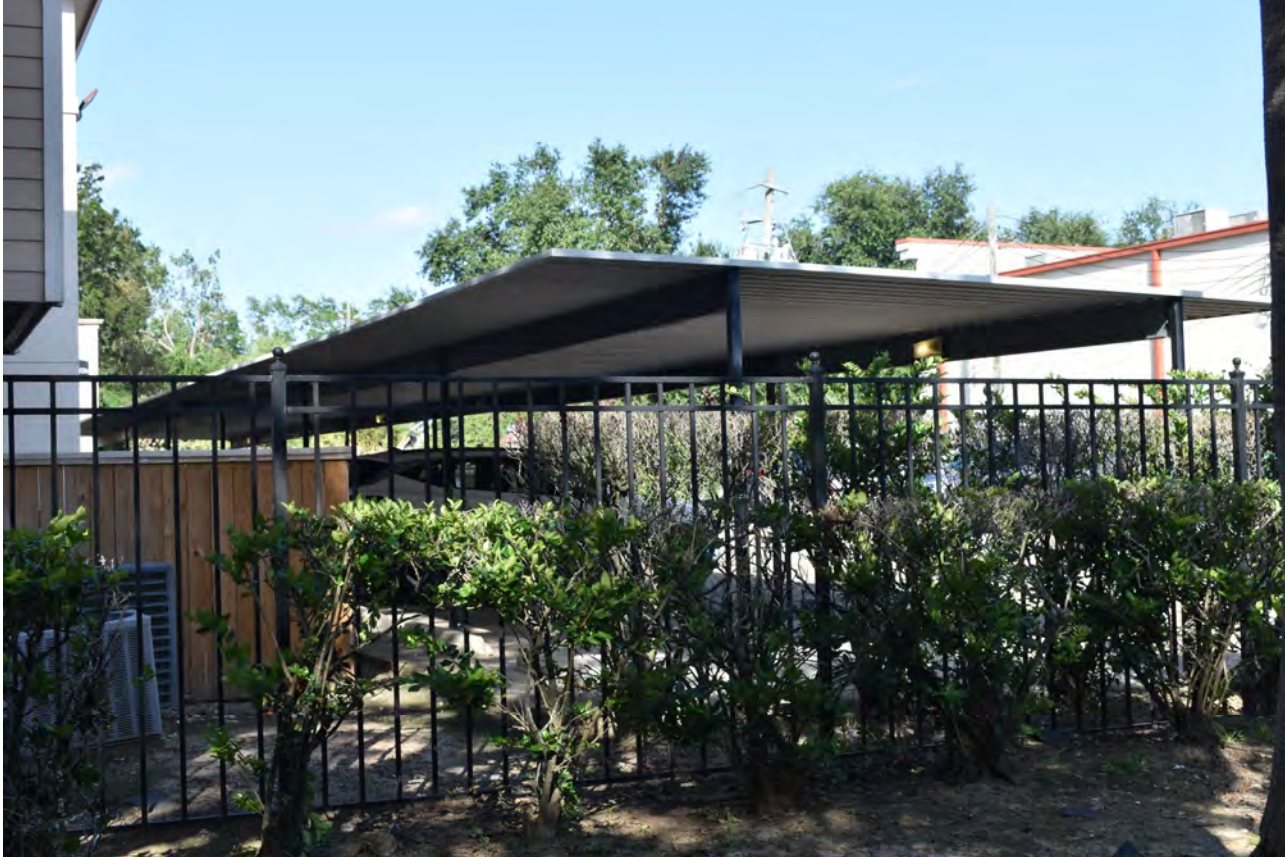
View facing  
east towards  
Resource 10R

Though these resources appear to retain integrity, they are not associated with significant events or individuals. The resources do not possess distinctive elements and is not a work of a master. The resources are unlikely to yield information potential. Therefore, the resources are recommended not eligible for the NRHP under Criteria A, B, C, or D.

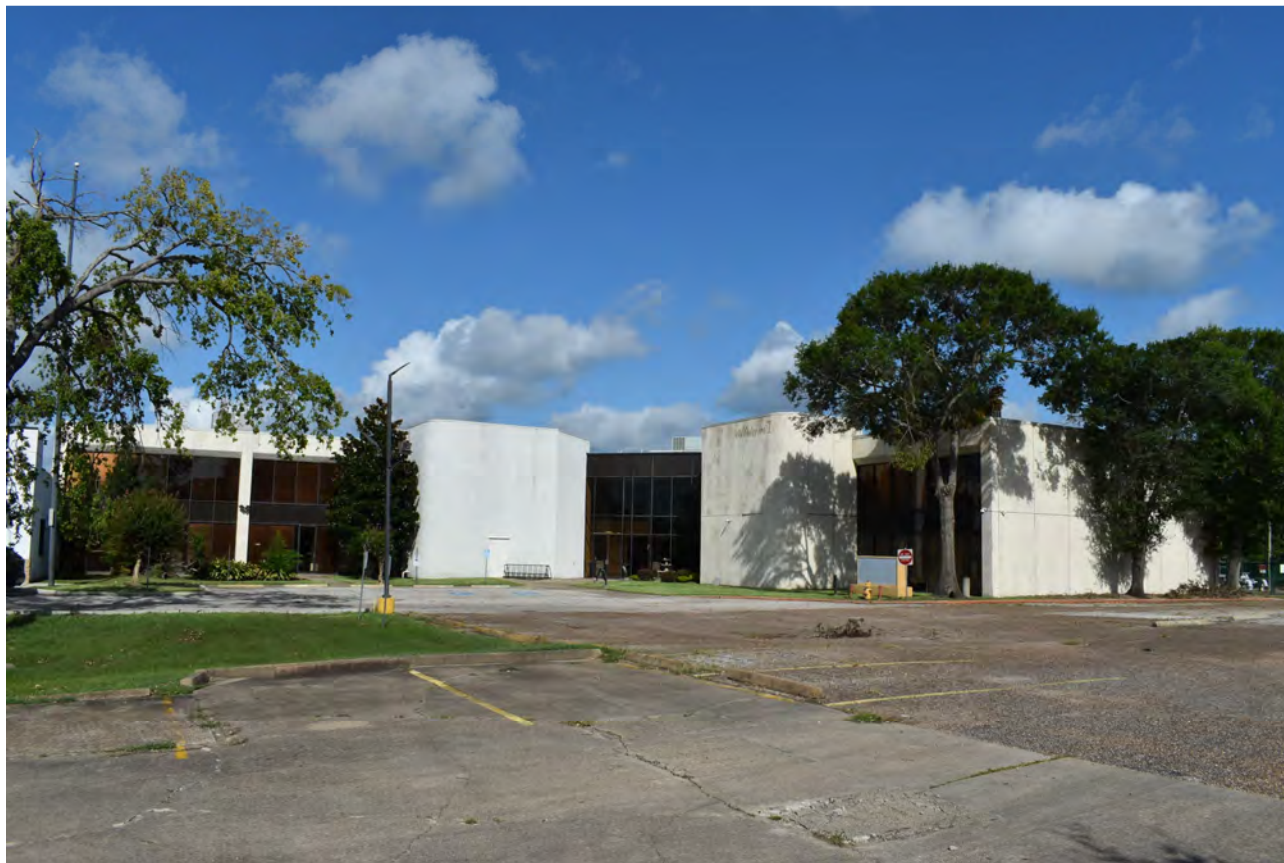
Resource 11A  
(Historic-age);  
view facing  
northwest  
towards  
original volume

This building is not associated with significant events or individuals. Although the building has some distinctive Late Modern architectural elements in its original volume, the massive addition to the street-facing facade takes away from the cohesive design of the building. This addition lessens integrity of design and materials, and removed signage further hinders integrity of materials. The resource is unlikely to yield information potential. Therefore, the resource is recommended not eligible for the NRHP under Criteria A, B, C, or D.

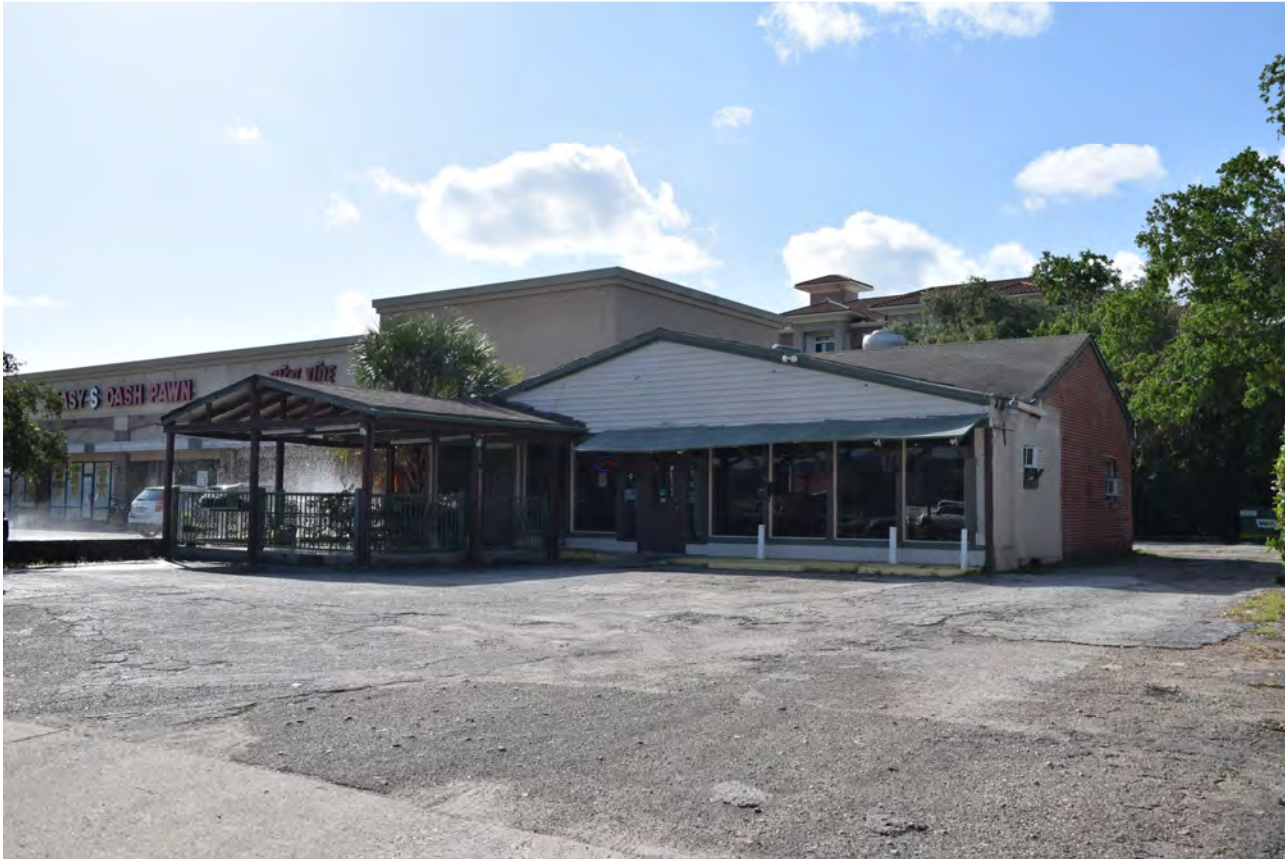
Resource 12A  
(Historic-age);  
view facing  
northwest

**Alterations:**  
Addition to front façade  
Awnings added  
Door(s) replaced (primary)  
Porch added  
Windows replaced (some)

This building is not associated with significant events or individuals. The building does not possess distinctive elements and is not a work of a master. Major additions detract from integrity of design. Replaced materials diminish integrity of materials. The resource is unlikely to yield information potential. Therefore, the resource is recommended not eligible for the NRHP under Criteria A, B, C, or D.
