APOLLO 10

LM-4

DESCENT PROPULSION SYSTEM

FINAL FLIGHT EVALUATION

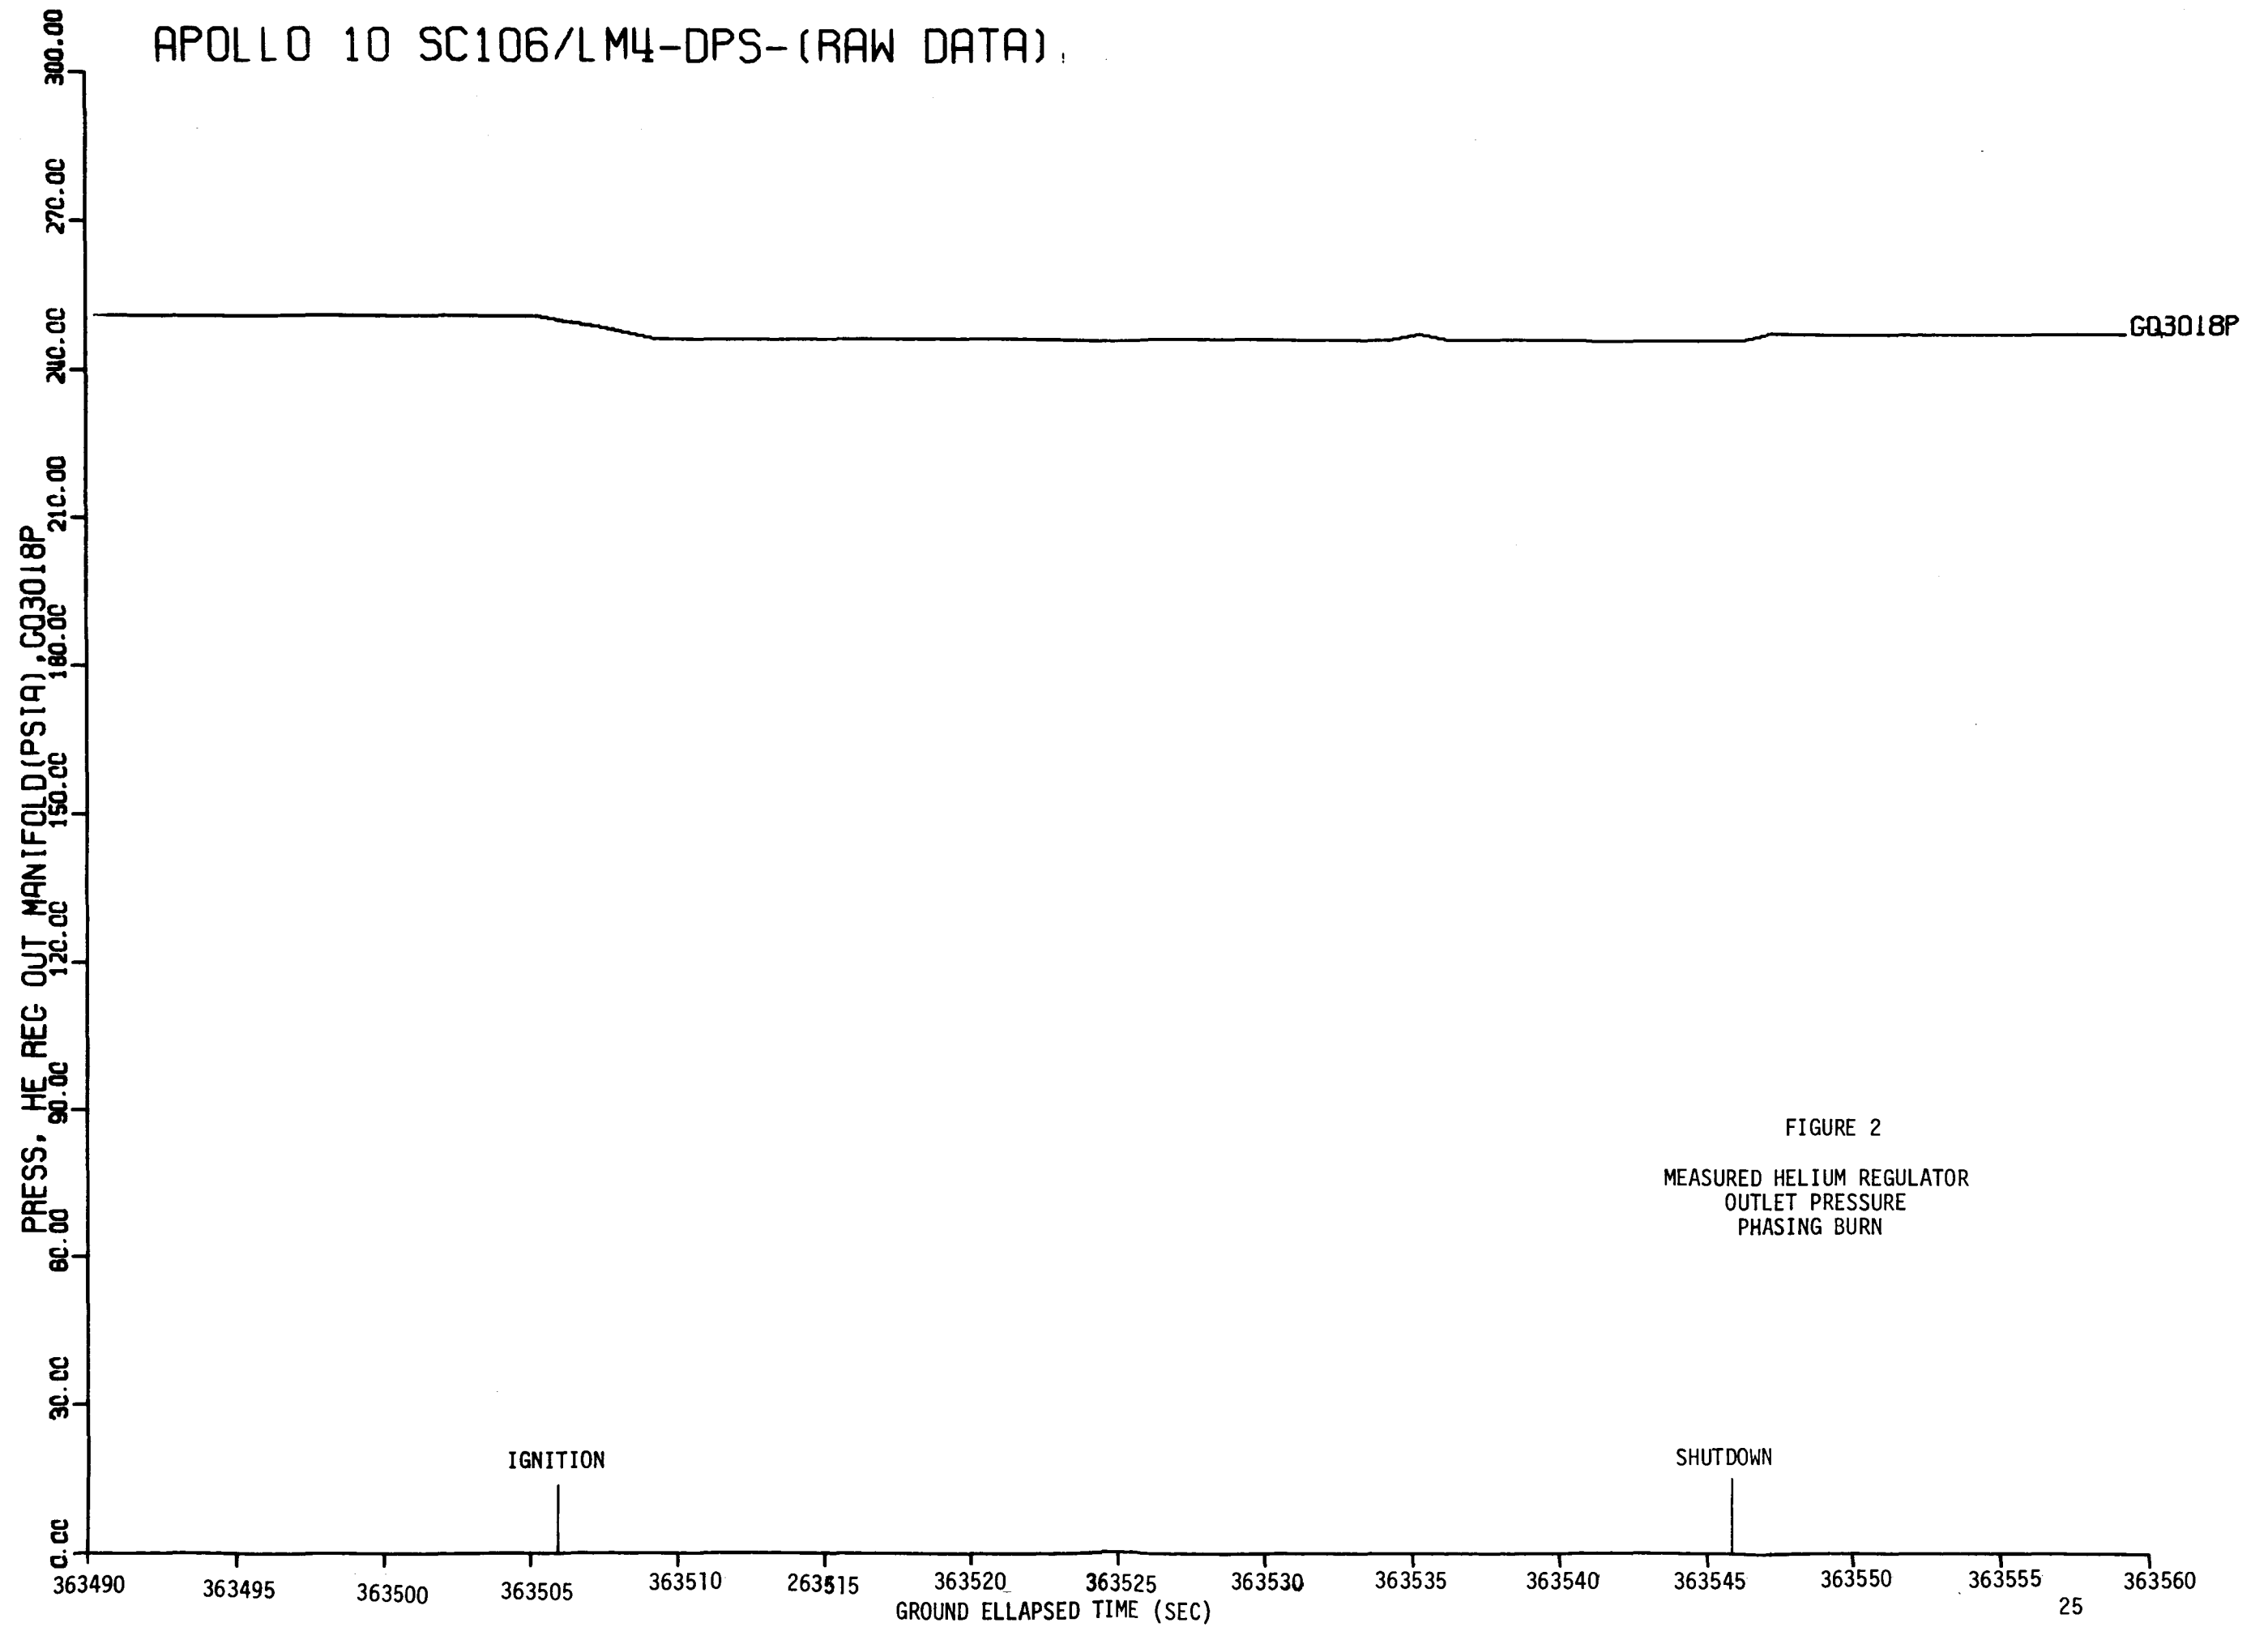
FIGURE 2
MEASURED HELIUM REGULATOR
OUTLET PRESSURE
PHASING BURN

Instrumentation biases were determined on the regulator outlet pressure measurement (GQ3018P), the oxidizer interface pressure measurement and the chamber pressure measurement with values of +4.0, +7.5 and -0.8 to -1.6 psi, respectively.

Upon activating the ambient helium start bottle in preparation for the DOI burn, DPS pressures appeared nominal with the exception of the oxidizer interface pressure measurement (GQ 4111P) and the redundant helium regulator outlet pressure measurement (GQ 3018P). At this time, the regulator outlet pressure (GQ 3025P) and fuel interface pressure (GQ 3611P) were approximately equal at 251 and 250 psia, respectively. The oxidizer interface pressure was 241 psia while the redundant regulator outlet pressure (GQ 3018P) was 247 psia. The chamber pressure measurement had a bias of from 0.8 to 1.6 psia prior to the burn. Simulation of an FTP time slice during the phasing burn indicated that the oxidizer pressure transducer must have incurred a downward shift. Had the interface pressure been as measured, the mean chamber pressure (with bias included) would have been more than one psi lower than observed. It was concluded that at FTP, the interface pressures were essentially equal and that there was a bias of approximately 7.5 psi on the oxidizer interface transducer. Similar reasoning, and the fact that the regulator outlet pressure as measured by GQ 3025P matched the predicted value during the burn, indicated that the regulator outlet pressure measurement (GQ 3018P) was biased low by approximately 4 psi. Table 3 presents the flight measurements for the Descent Propulsion System.

Table 4 presents the inflight measured data at typical points during each of the two throttle positions experienced in the Phasing Burn. The preflight predicted values, obtained from Reference 5, are also presented for comparison. The inflight measured data compares well with preflight predicted data. Deviations at the minimum throttle setting (FS-1 + 10 seconds) are due to the difference between flight and predicted throttle setting. Although detailed performance analysis could not be made, the flight data was used in the prediction model to give an indication of approximate inflight performance. The results are also presented in Table 4. Figure 1 through 9 present DPS inflight measured supercritical helium tank pressure, regulator outlet pressure, interface pressures, chamber pressure and gaging system readings during the Phasing Burn.

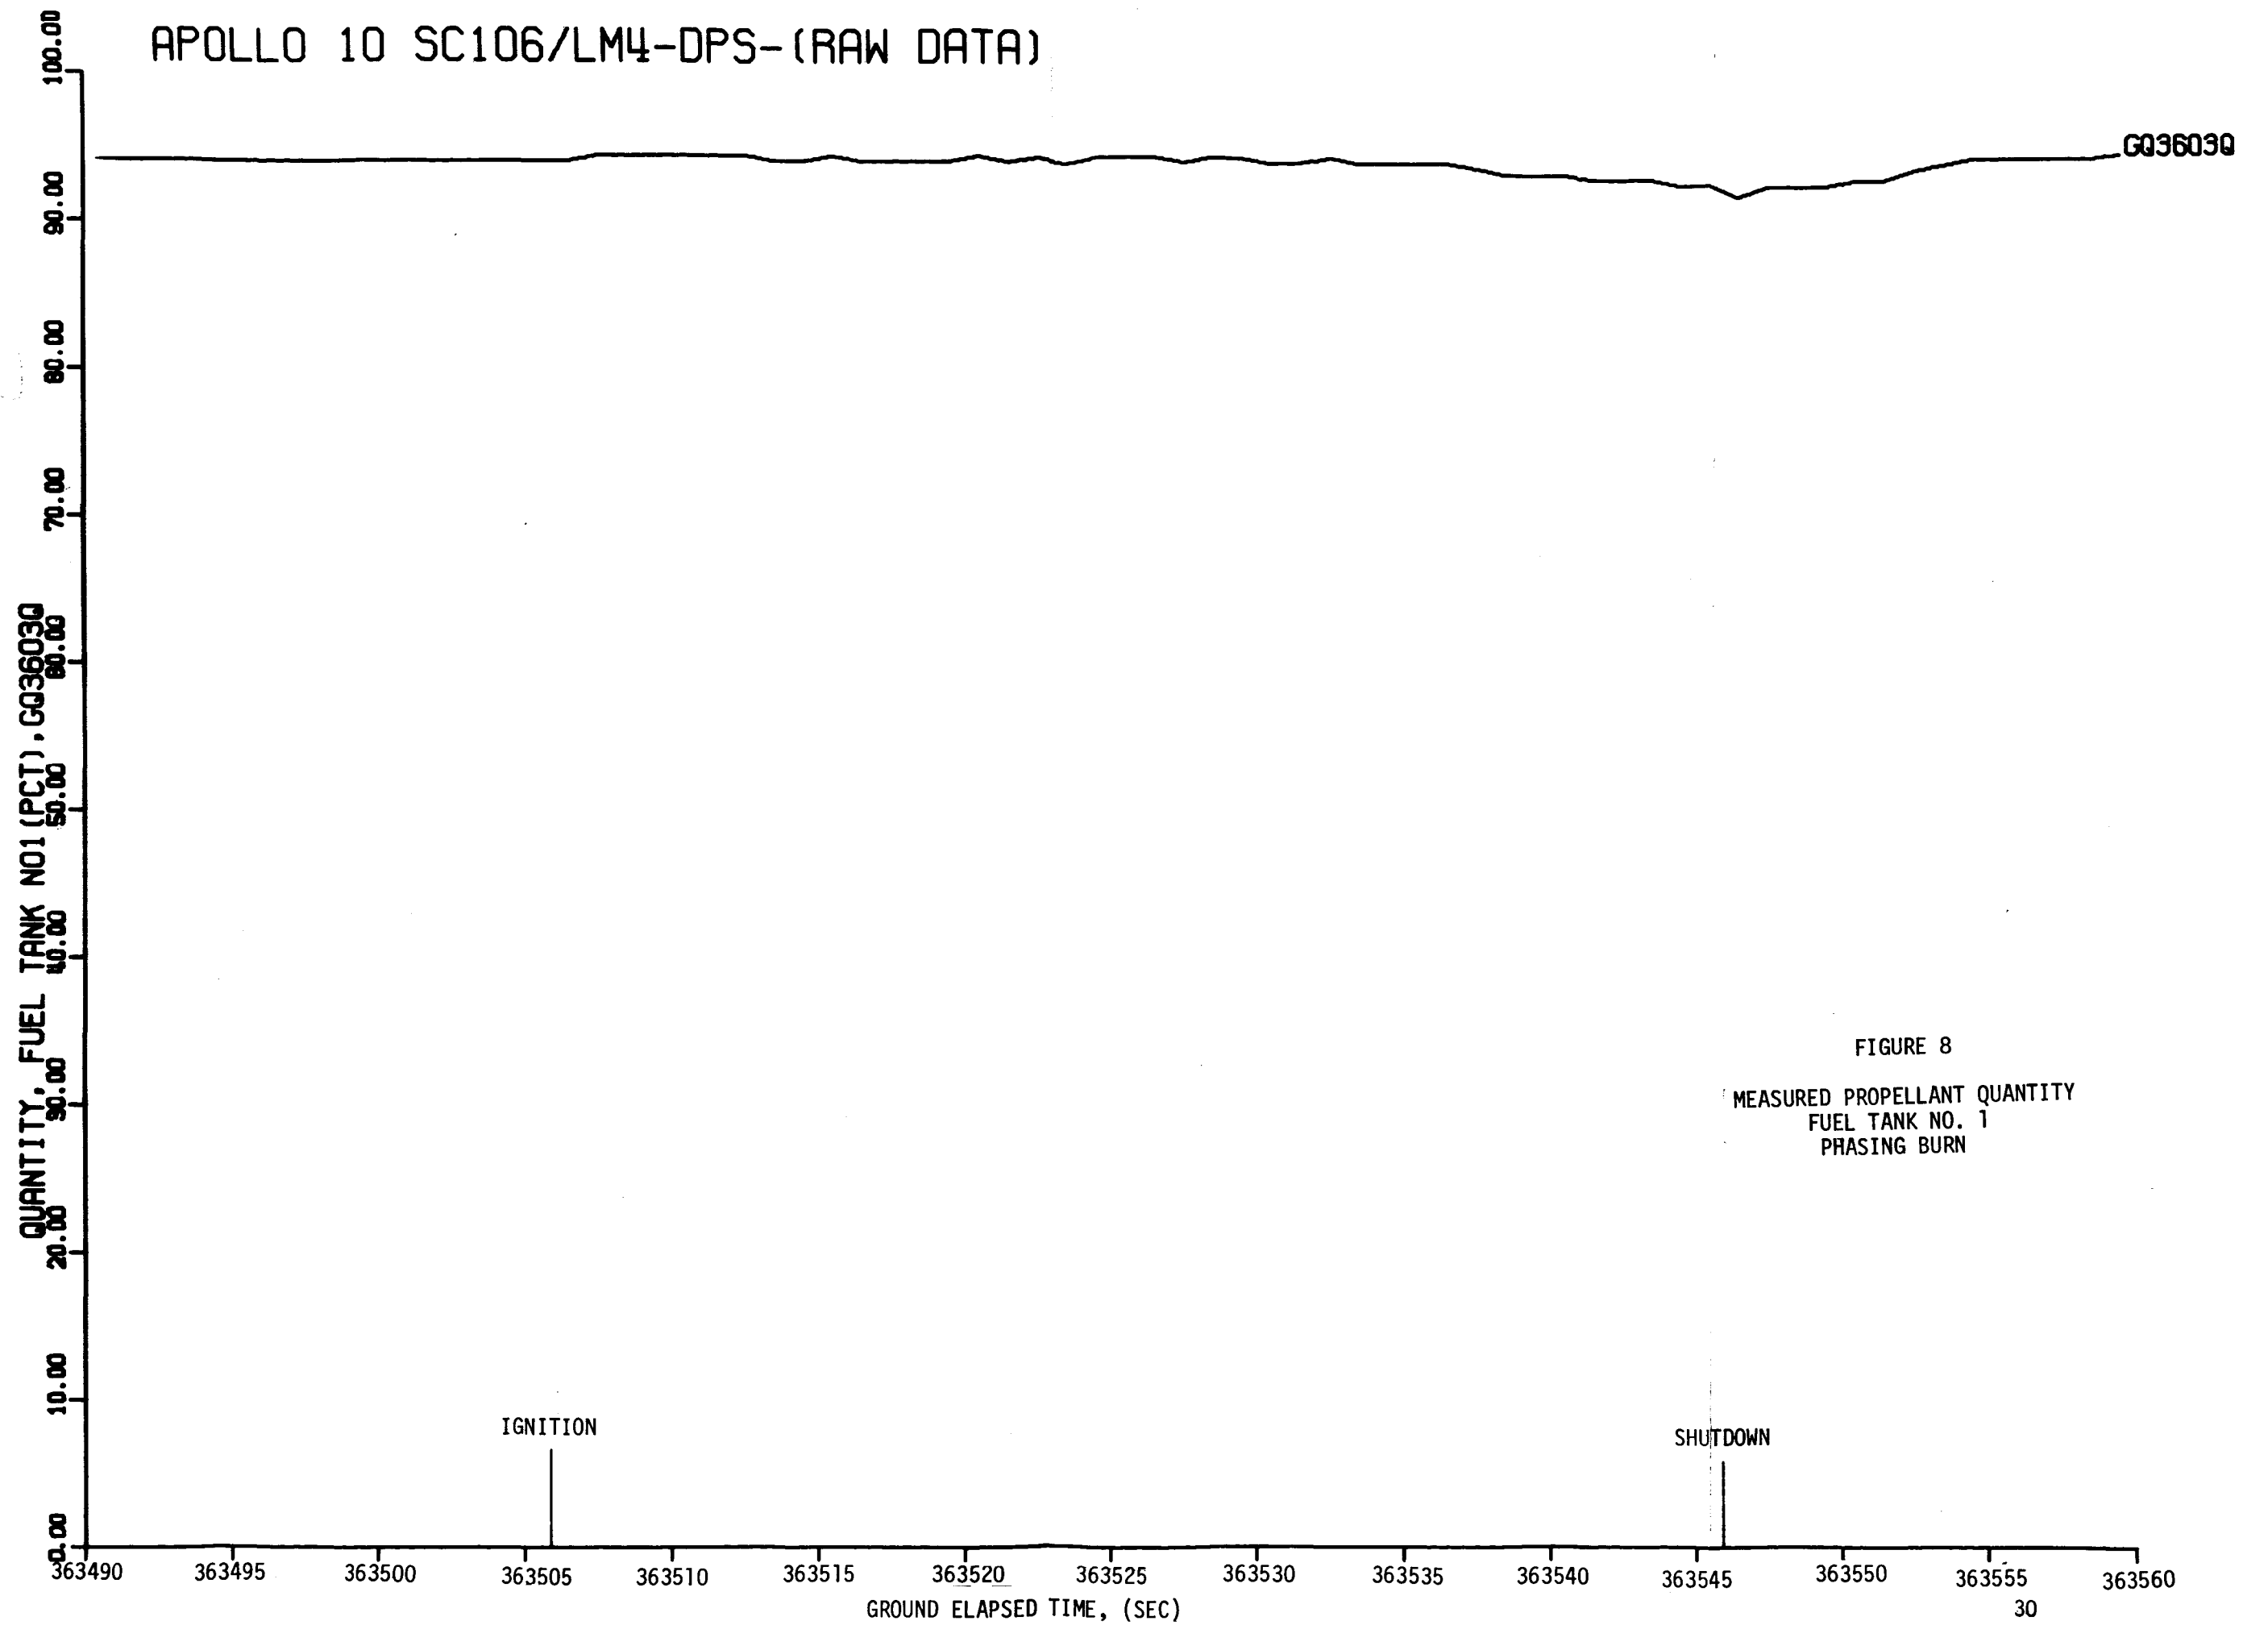
FIGURE 8
MEASURED PROPELLANT QUANTITY
FUEL TANK NO. 1
PHASING BURN

At engine ignition for the second DPS burn, the oxidizer propellant gages (Ox 1 and Ox 2) were reading off scale, as expected (greater than the maximum 95 percent indication). The fuel tank probes (Fu 1 and Fu 2) had readings of 94.2 and 94.5 percent, respectively. Based on the best estimate of consumed propellant during the DOI maneuver, the fuel tank measurements should also have been reading off scale at ignition. This deviation was also noted prior to launch. After ignition, the fuel quantities remained relatively constant for approximately 31 and 27 seconds for Fu 1 and Fu 2, respectively, at which time propellant consumption was indicated. The oxidizer gages began to show consumption at approximately 35 and 37 seconds for Ox 1 and Ox 2, respectively. At the end of the burn, the propellant gages were reading 92.4, 92.0, 93.8 and 94.5 percent for Fu 1, Fu 2, Ox 1 and Ox 2, respectively. Table 5 presents a comparison of the measured data and the best estimate of the actual values at the end of the Phasing Burn. Although the Ox 2 gage is outside the specification limits of 1.3%, it should be noted that the lack of data from the DOI burn somewhat compromises the calculated values. Although initially giving erroneous output, the fuel gages appeared to be functioning within specification limits at engine shutdown. All values were within the expected accuracies of 2.7% and 3.5% for oxidizer and fuel (Reference 7). These accuracies were developed from recent tests conducted at the White Sands Test Facility (WSTF).

The failure of the fuel gages to reach a maximum reading when greater than that amount of propellant was in the tanks has been attributed to either chemical reaction with alodine or aluminum impurities with the fuel, or contamination of the fuel sensors due to the referee propellant (used

instead of live propellants in probe manufacture and calibration) or alodine surface treatment (Reference 8). A chemical reaction between the fuel and impurities, which are not clearly understood, could cause an insulating barrier to be set up such that the conductance within the sensing portion of the gaging system probe is reduced, thus causing a reduction in the full scale reading. This barrier could be in the form of bubbles forming on the inner electrode when the sensor is submerged in stagnant fuel. A small quantity of residual from the reference propellant or from the alodine surface treatment of the gage (prior to installation) could combine with the propellant and form a conductive component in the fuel that settles in the reference region at the bottom of the gaging probe causing the signal to be low at gage activation. For either of these to happen, the propellant would have to be in a stagnant condition. It was thus concluded in Reference 8 that under zero gravity conditions, these problems should not occur, particularly due to RCS and SPS activities which would tend to keep the propellant reasonably active inside the tanks. In the case of this flight, it is possible that the propellant movement prior to engine burn was not great enough to remove contamination from the reference region.
