MSC APOLLO 13 INVESTIGATION TEAM

FINAL REPORT

RELATED SYSTEMS EVALUATION

VOLUME II
LUNAR MODULE

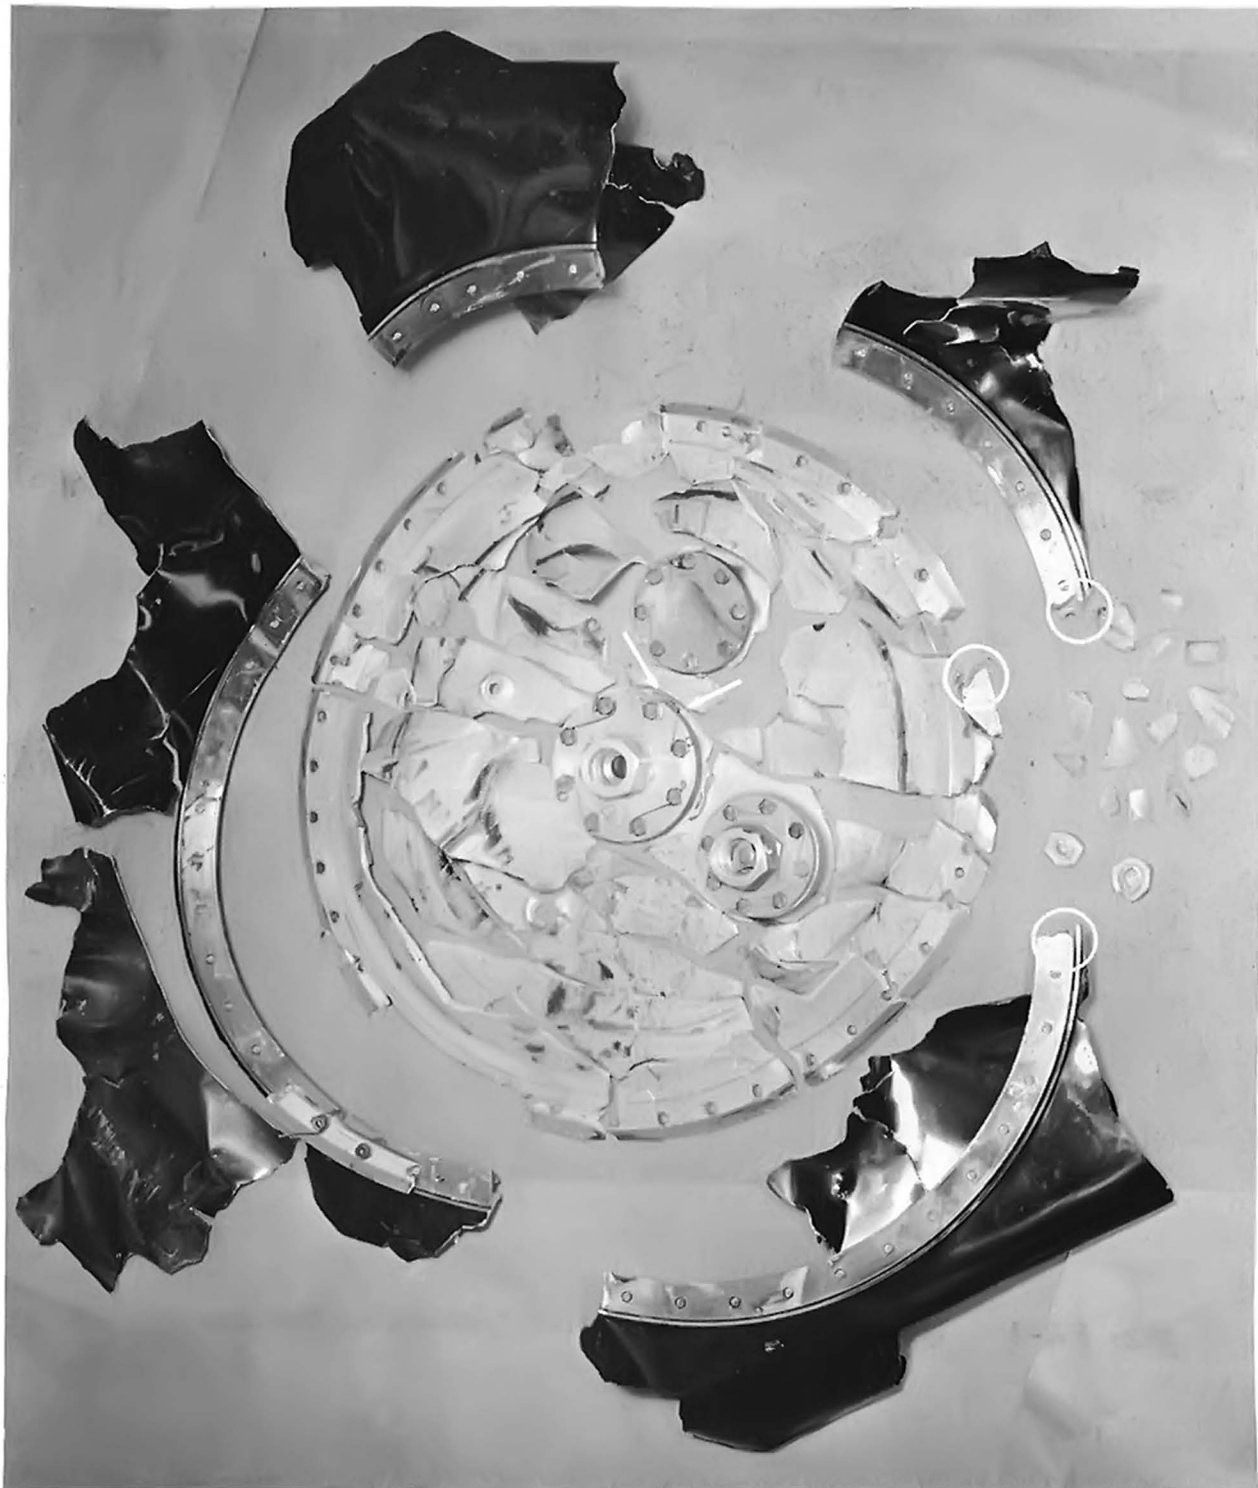
Fig. 5.2-2 Reassembled Pieces of DPS Propellant Tank Cover

Tank 55 (S/N G-029), was failed catastrophically during a helium leak test (Reference Figures 5.2-1 through 5.2-4) on 23 August 1966. Pressure in the tank assembly was being increased for the high pressure (270 psig) leak test. A pressure of 180 psig had just been recorded when failure occurred. The failure occurred while the tank assembly was inside a helium collection chamber. The tank shattered into many pieces and the helium collection chamber and adjacent equipment were severely damaged. The failure investigation disclosed that the failure originated in the 20140T651 aluminum cover. The cause of failure was stress corrosion, possibly resulting from a 360 psig proof test with demineralized water which the cover received thirteen days earlier. The corrective action was to substitute titanium covers for the aluminum. No tanks with aluminum covers have been, or are, used on flight vehicles. No failures have occurred with titanium covers.

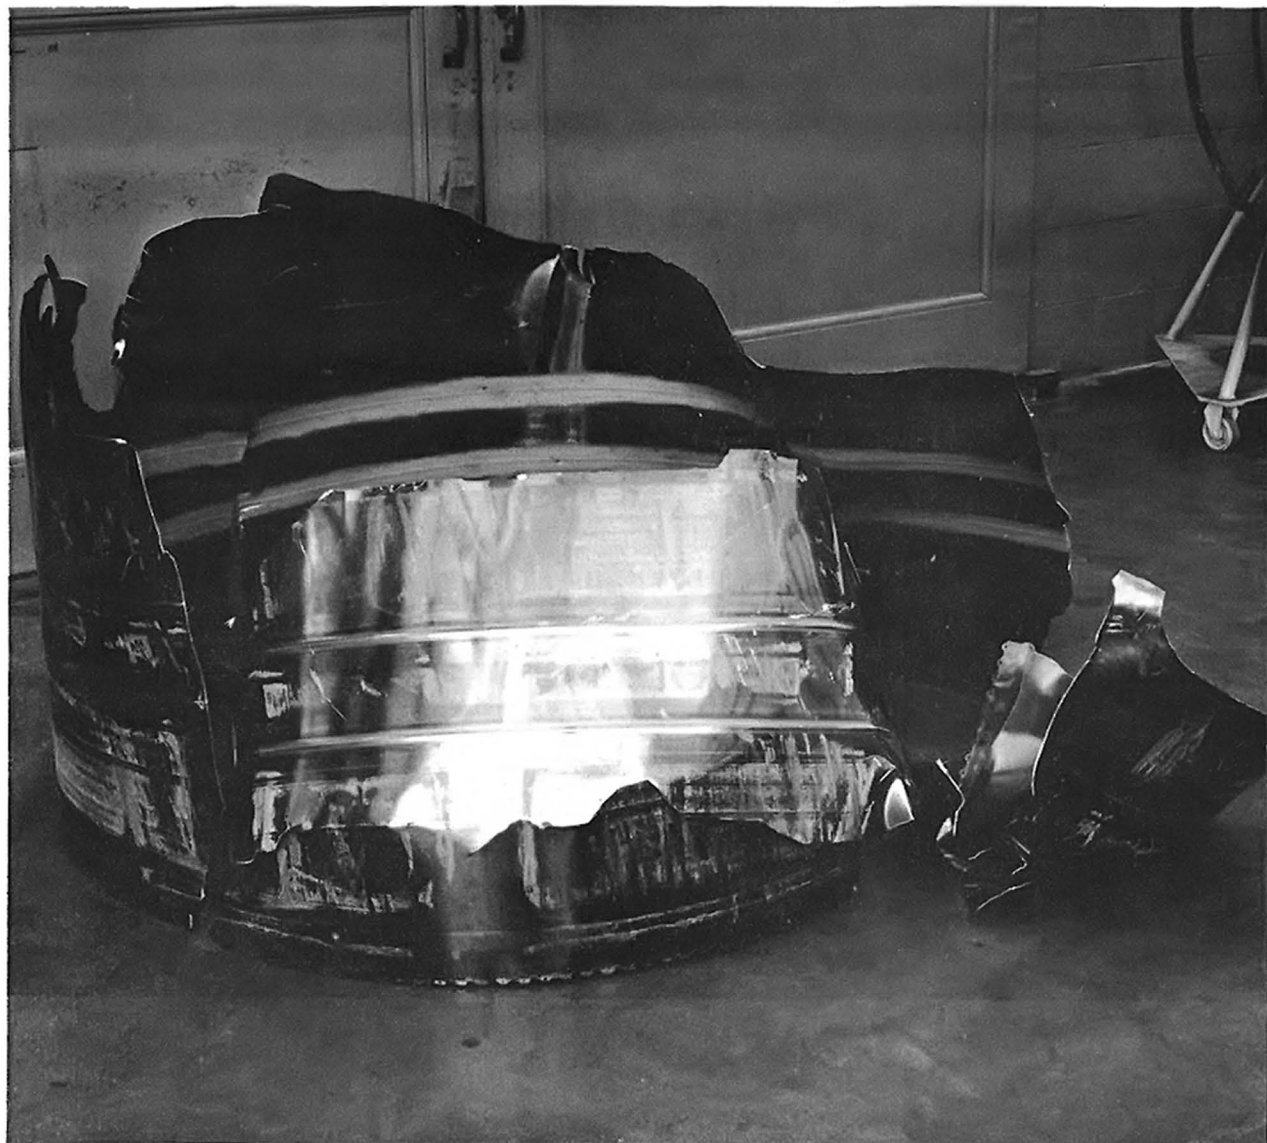
Fig. 5.2-3 DPS Propellant Tank Failed Cylindrical Section

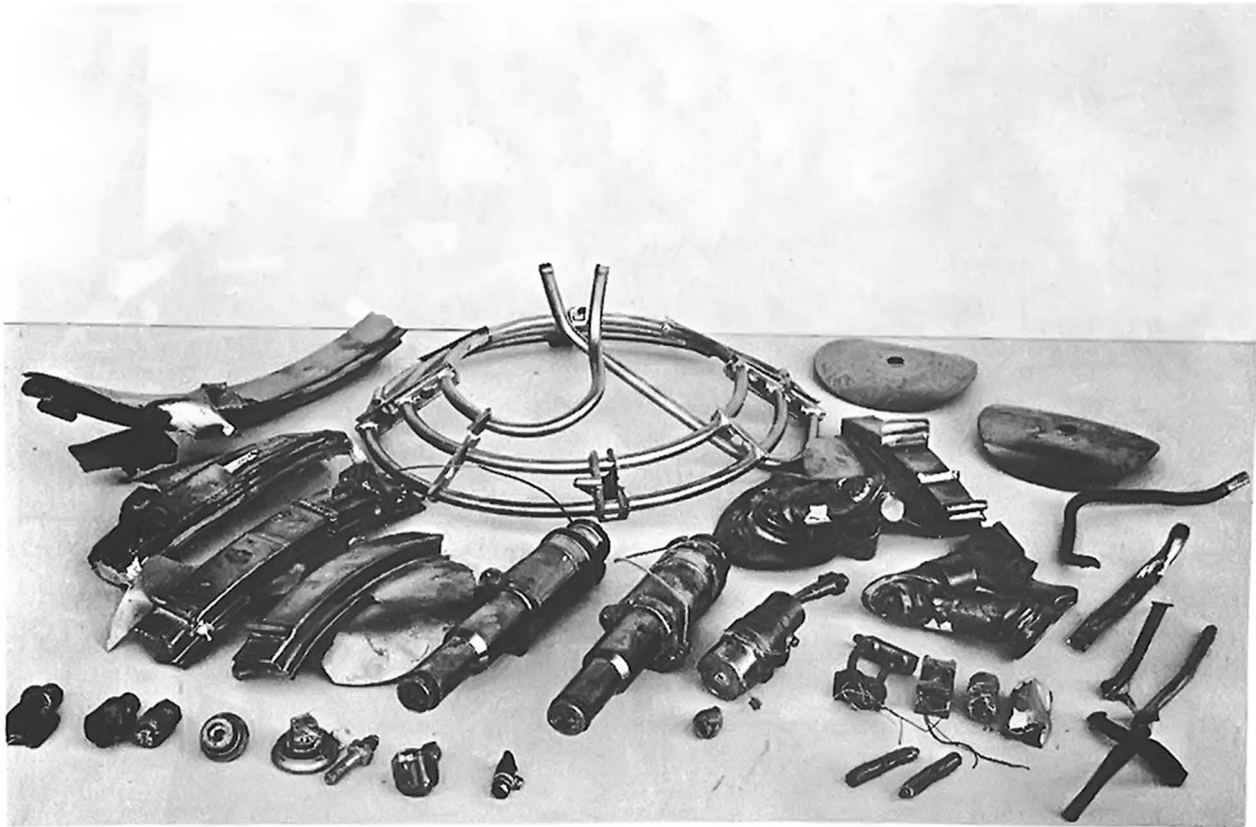
Fig. 5.2-9 SHe Tank Pieces After Pneumatic Rupture

One SHe tank was pneumatically tested to actual burst pressure; the test results are presented in Table 5.1-1. The results of a SHe tank burst can be seen in Figures 5.2-5 through 5.2-9.

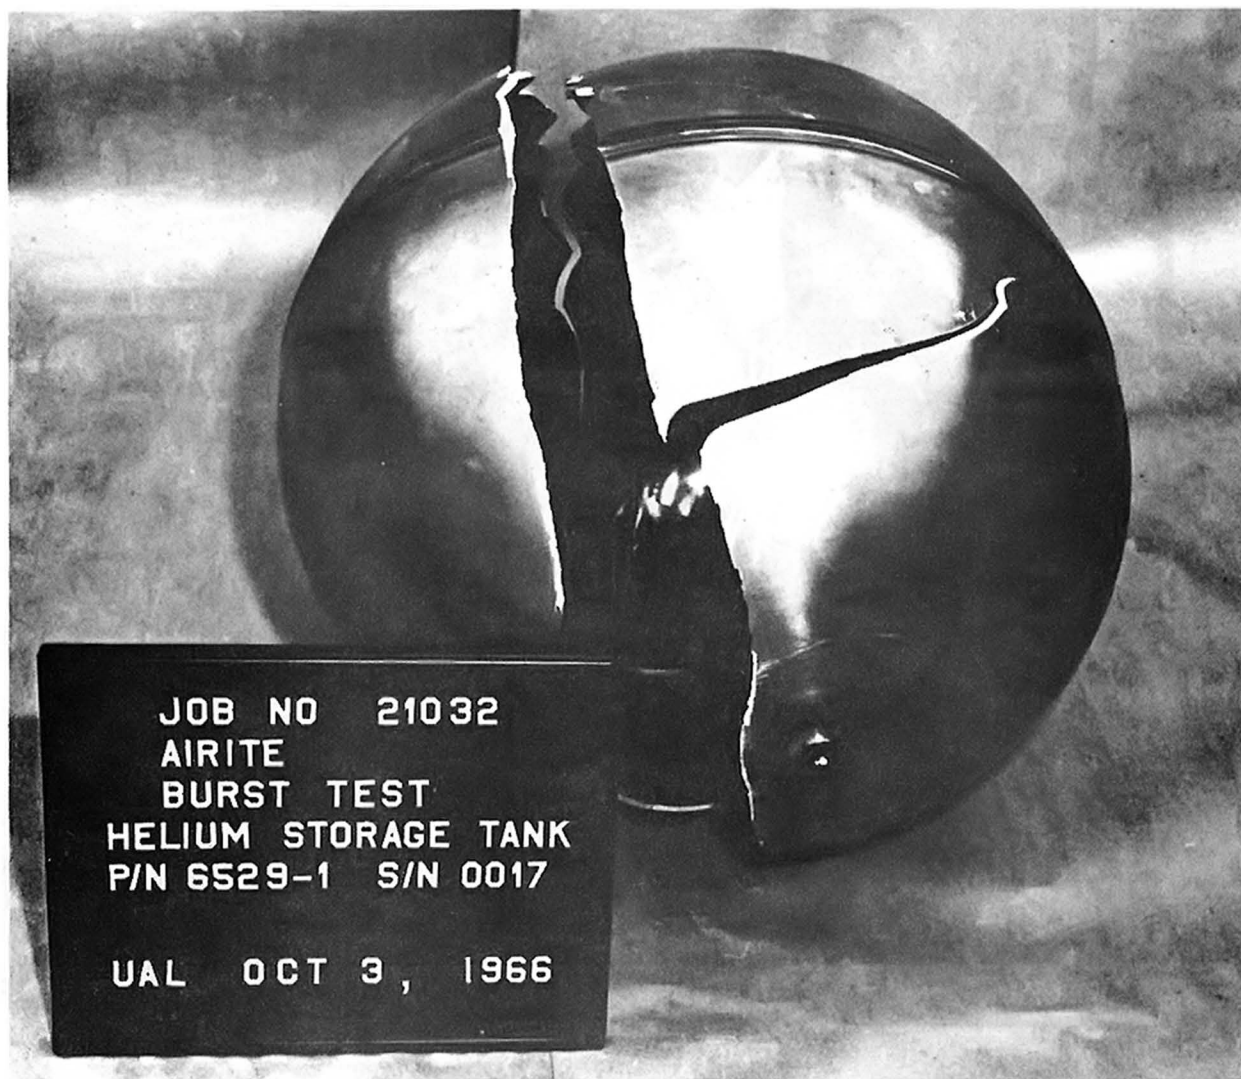
JOB NO 21032
AIRITE
BURST TEST
HELIUM STORAGE TANK
P/N 6529-1 S/N 0017

Fig. 5.3-2 APS He Tank After Hydrostatic Rupture

The burst test data are summarized in Table 5.1-1. Figure 5.3-2 shows the results of a hydrostatic tank failure.

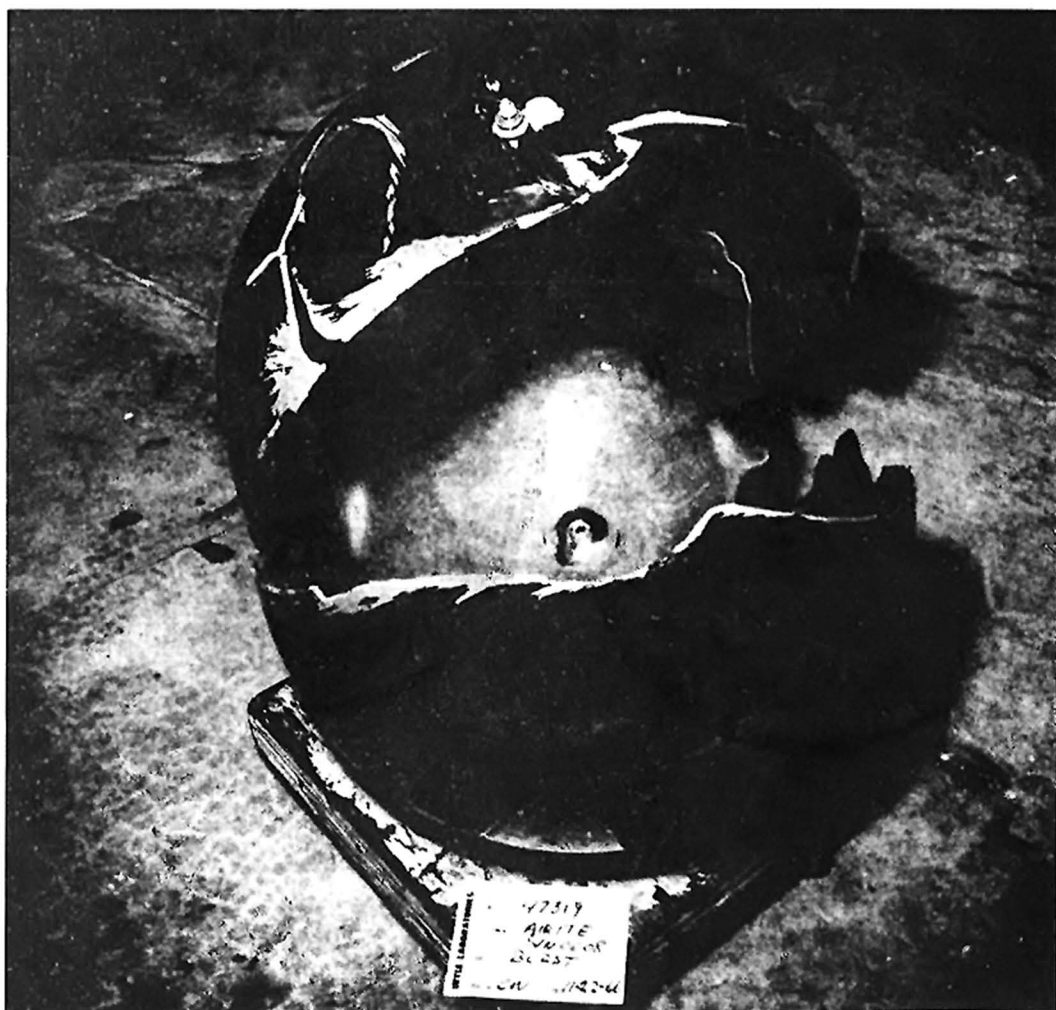
Fig. 5.5-1 ECS D/S GOX Tank After Hydrostatic Rupture

Six descent oxygen tanks were hydrostatically tested to burst; test results are summarized in Table 5.1-1. Figure 5.5-1 shows the typical results of a hydrostatic failure.

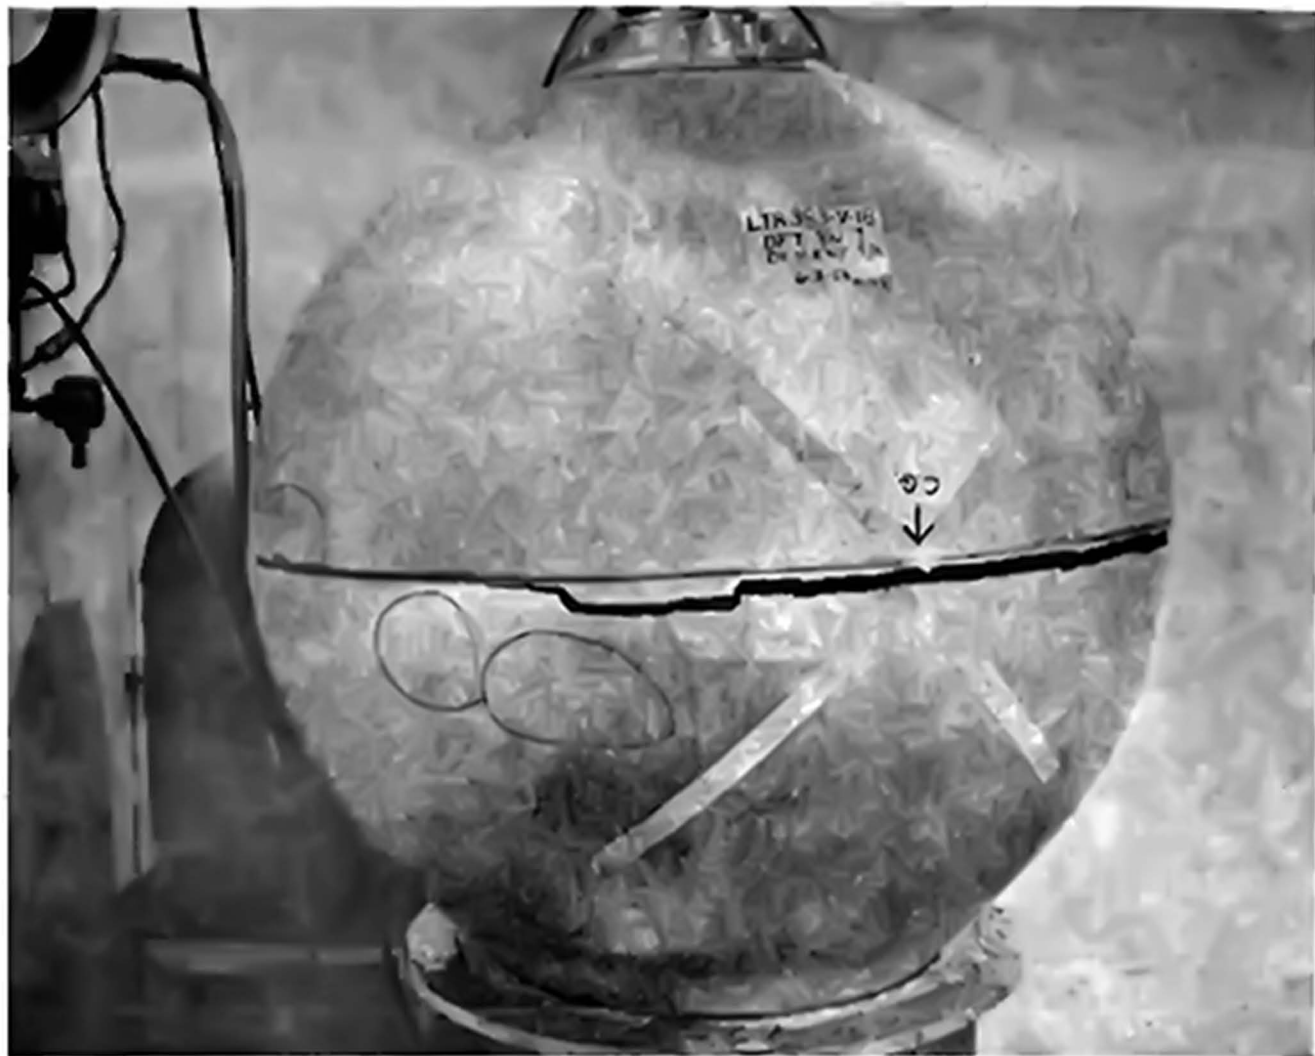
Fig. 5.5-4 ECS D/S Water Tank After Hydrostatic Rupture

One descent water tank was hydrostatically tested to burst; test results are summarized in Table 5.1-1. The failed tank is shown in Figure 5.5-4.
