## 4. Soil Mechanics Experiment

*J. K. Mitchell,<sup>a†</sup> L. G. Bromwell,<sup>b</sup> W. D. Carrier III,<sup>c</sup> N. C. Costes,<sup>d</sup>  
and R. F. Scott<sup>e</sup>*

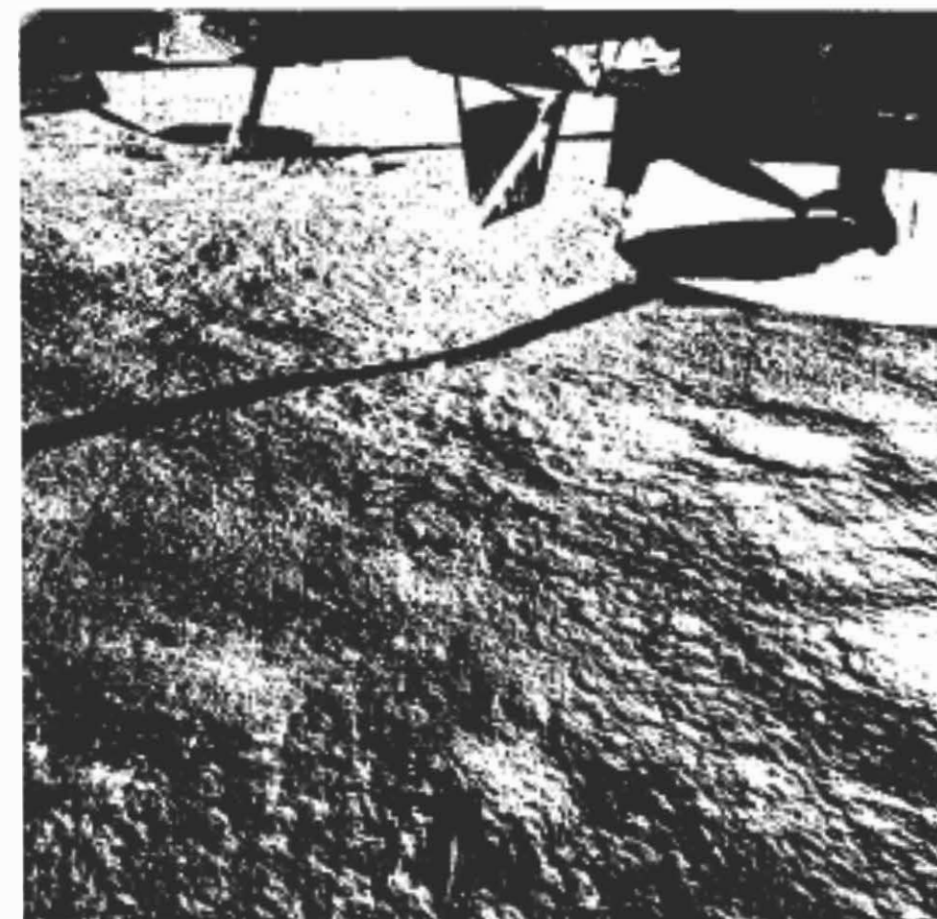
FIGURE 4-3.—Area below the descent-engine nozzle showing erosional features caused by the exhaust gas. The  $-Y$  footpad can be seen in the distance (AS14-66-9262).

erosion in an area approximately 1 m southeast of the region below the engine nozzle. They noted that as much as 10 cm of surface material may have been removed during the landing. A distinct erosional pattern is visible in figure 4-3, which shows the area below the descent-engine nozzle. Except for a disturbed area in the left middle distance, the surface gives the appearance of having been swept by engine gases in the same way as had occurred on previous missions. The disturbed area may have developed as a consequence of a grazing contact of the  $+Y$  footpad contact probe during the landing. It was noted in a previous report (ref. 4-1) that such a disturbance to the lunar surface breaks up the surface material and renders it more susceptible to engine-exhaust erosion.

Some of the tilting of the spacecraft can be explained by an examination of the footpads. The  $-Y$  (fig. 4-3) and  $-Z$  footpads have penetrated the surface only to a depth of 2 to 4 cm, whereas the  $+Y$  (fig. 4-2) and  $+Z$  footpads have penetrated to a depth of 15 to 20 cm. The  $+Y$  footpad penetration mechanism is clearly visible in figure 4-4; the footpad contacted and plowed into the rim of a 2-m-diameter crater. The motion of the footpad through the soil caused a buildup of a mound of soil on the north side of the pad. The height of the mound is somewhat higher than the actual penetration depth of the footpad. The astronauts reported that the  $+Z$  footpad, which is in the shadow of the LM, also landed on the rim of a small crater and exhibited appearance and penetration characteristics similar to the appearance and penetration characteristics of the  $+Y$  footpad. The mechanical properties of the soil, which are inferred from the response of the soil to the landing (which occurred with little or no shock-absorber stroking) and from the appearance of the soil in the footpad photographs, appear to be similar to the mechanical properties of the lunar material on which the Apollo 11 and 12 LM's landed.
