Comparison photographs of the Apollo 11 Lunar Television

as seen at Goldstone, Honeysuckle Creek, Parkes and Houston.

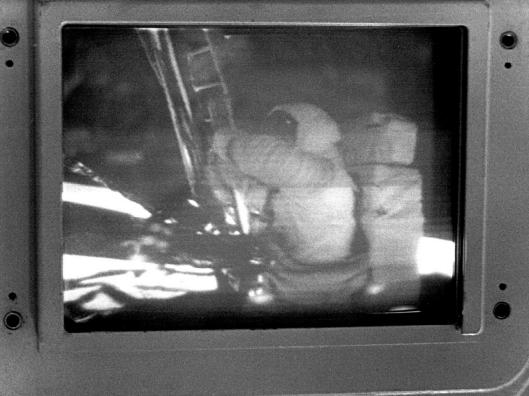
Honeysuckle Creek – slow scan TV monitor at Honeysuckle

Slow scan picture. Handheld 35mm SLR photo, taken at Honeysuckle Creek. (HSK-TV05)

GET 109:29:18 Armstrong installing the LEC on the secondary strut. Compare the scan converted TV sent from Goldstone

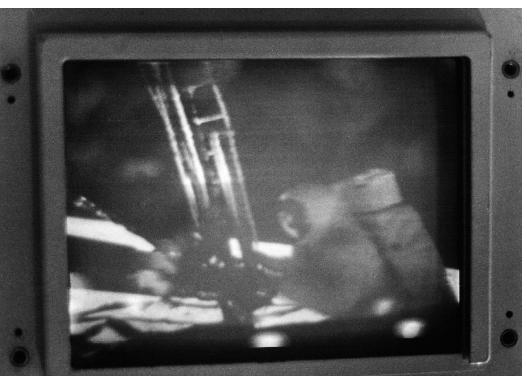
Honeysuckle Creek – slow scan TV monitor at Honeysuckle

Slow scan picture. Handheld 35mm SLR photo, taken at Honeysuckle Creek. (HSK-TV03)

GET 109:25:30 Armstrong on the surface.

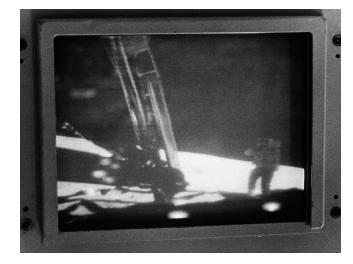
Honeysuckle Creek – slow scan TV monitor at Honeysuckle

Slow scan picture. Handheld 35mm SLR photo, taken at Honeysuckle Creek. (HSK-TV04)

Armstrong deploys the Lunar Equipment Conveyor (LEC).

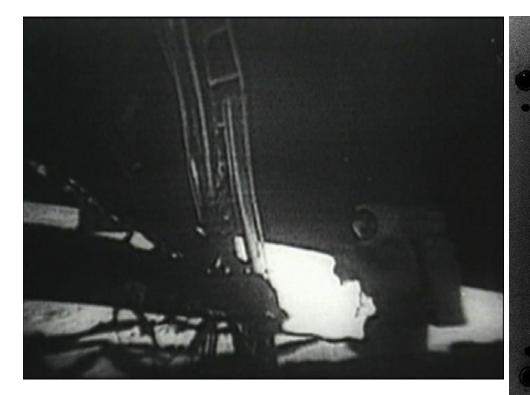
Parkes – scan converted video at Houston

Scan converted picture. Kinescope of TV at Houston. Honeysuckle Creek – slow scan TV monitor at Honeysuckle

Slow scan picture. Handheld 35mm SLR photo, taken at Honeysuckle Creek. (HSK-TV06)

GET 109:31:00 Armstrong talking Aldrin down.

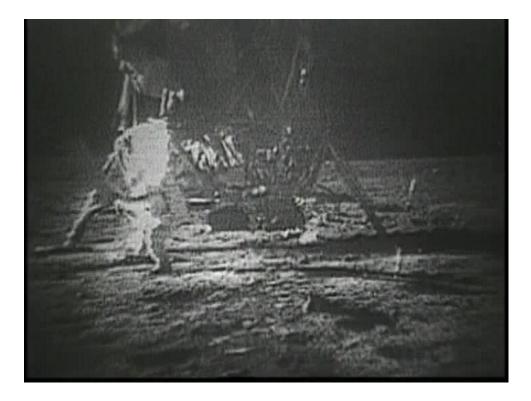
Parkes – scan converted video at Houston

Scan converted picture. Kinescope of TV at Houston.

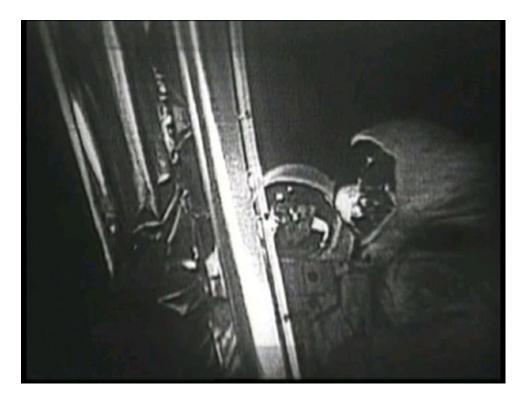
Parkes – scan converted video at Houston

Scan converted picture. Kinescope of TV at Houston.

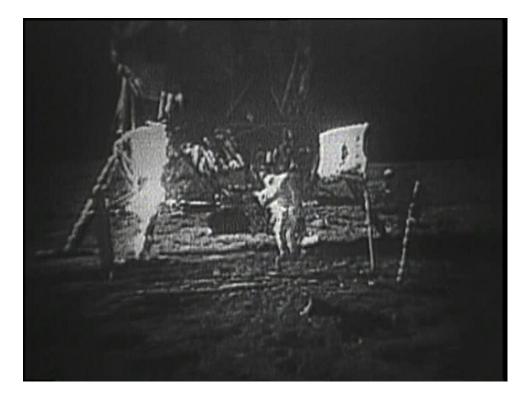
Parkes – scan converted video at Houston

Scan converted picture. Kinescope of TV at Houston.

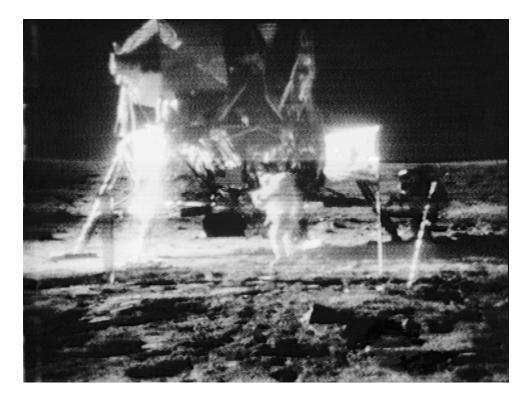
Goldstone – slow scan TV monitor at Goldstone

Slow scan picture. Mounted Polaroid, taken at Goldstone. (Photo with thanks to Bill Wood)

GET 110:41:48

Buzz (left) and Neil (right) as Buzz gives a reading on his oxygen levels.

Image at 110:41:48 GET – a ounted Polaroid taken at Goldstone by a Goddard PAO representative, preserved and scanned by Goldstone Unified S-band Lead Engineer Bill Wood.
