Volume V

Appendix G.4

Group 1 Matrix Brief on Maintenance, Material, and Management

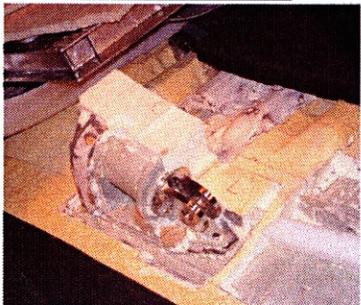
Complex spray areas around bipod fixture

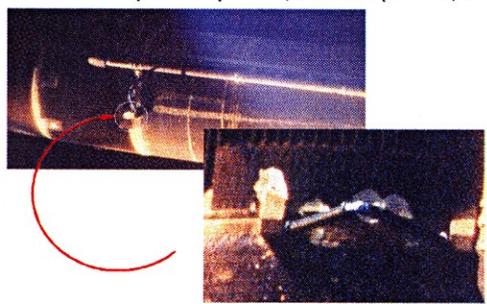
Loss of –Y Bipod Ramp Foam, STS-32R (OV-102, ET-32)

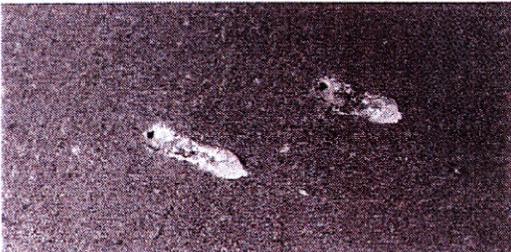
Typical Pinholes (1992) First Discovered on OV-102-12

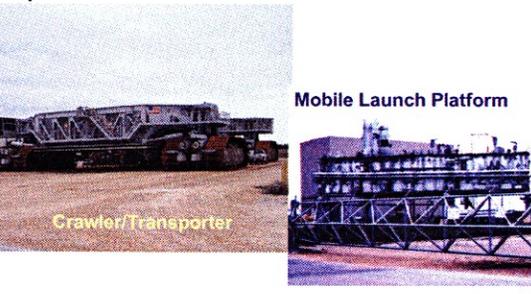
Aging Equipment C/T and MLP

Mobile Launch Platform

Crawler/Transporter
