REPORT OF APOLLO 204 REVIEW BOARD

APPENDIX D
PANELS 6 thru 10

**REPORT OF PANEL 6
HISTORICAL DATA
APPENDIX D-6
TO
FINAL REPORT OF
APOLLO 204 REVIEW BOARD**

**REPORT OF PANEL 10
ANALYSIS OF FRACTURE AREAS
APPENDIX D-10
TO
FINAL REPORT TO
APOLLO 204 REVIEW BOARD**

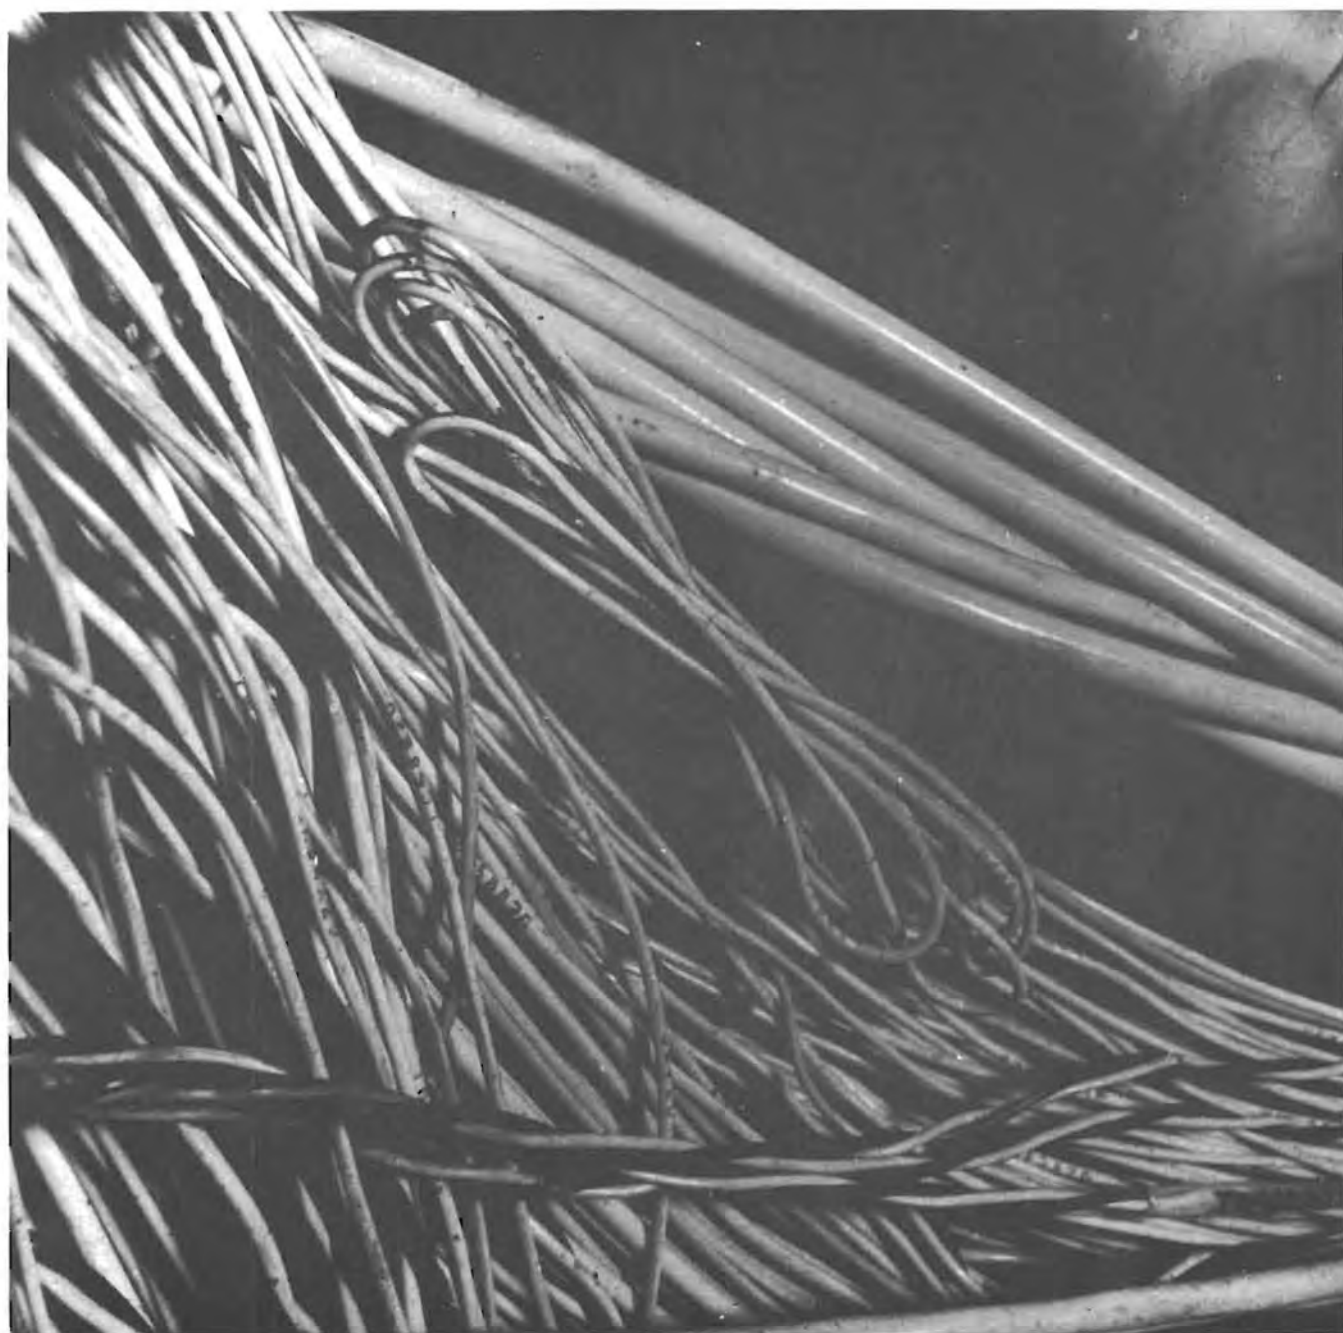
ENCLOSURE 9-6

WIRING ASSESSMENT
